The Cathedral and Metropolitan Church of St Peter in York, also known as York Minster

Re-lead windows s20 - s22.

Windows s20 – s22

An Update on Condition and Consequences

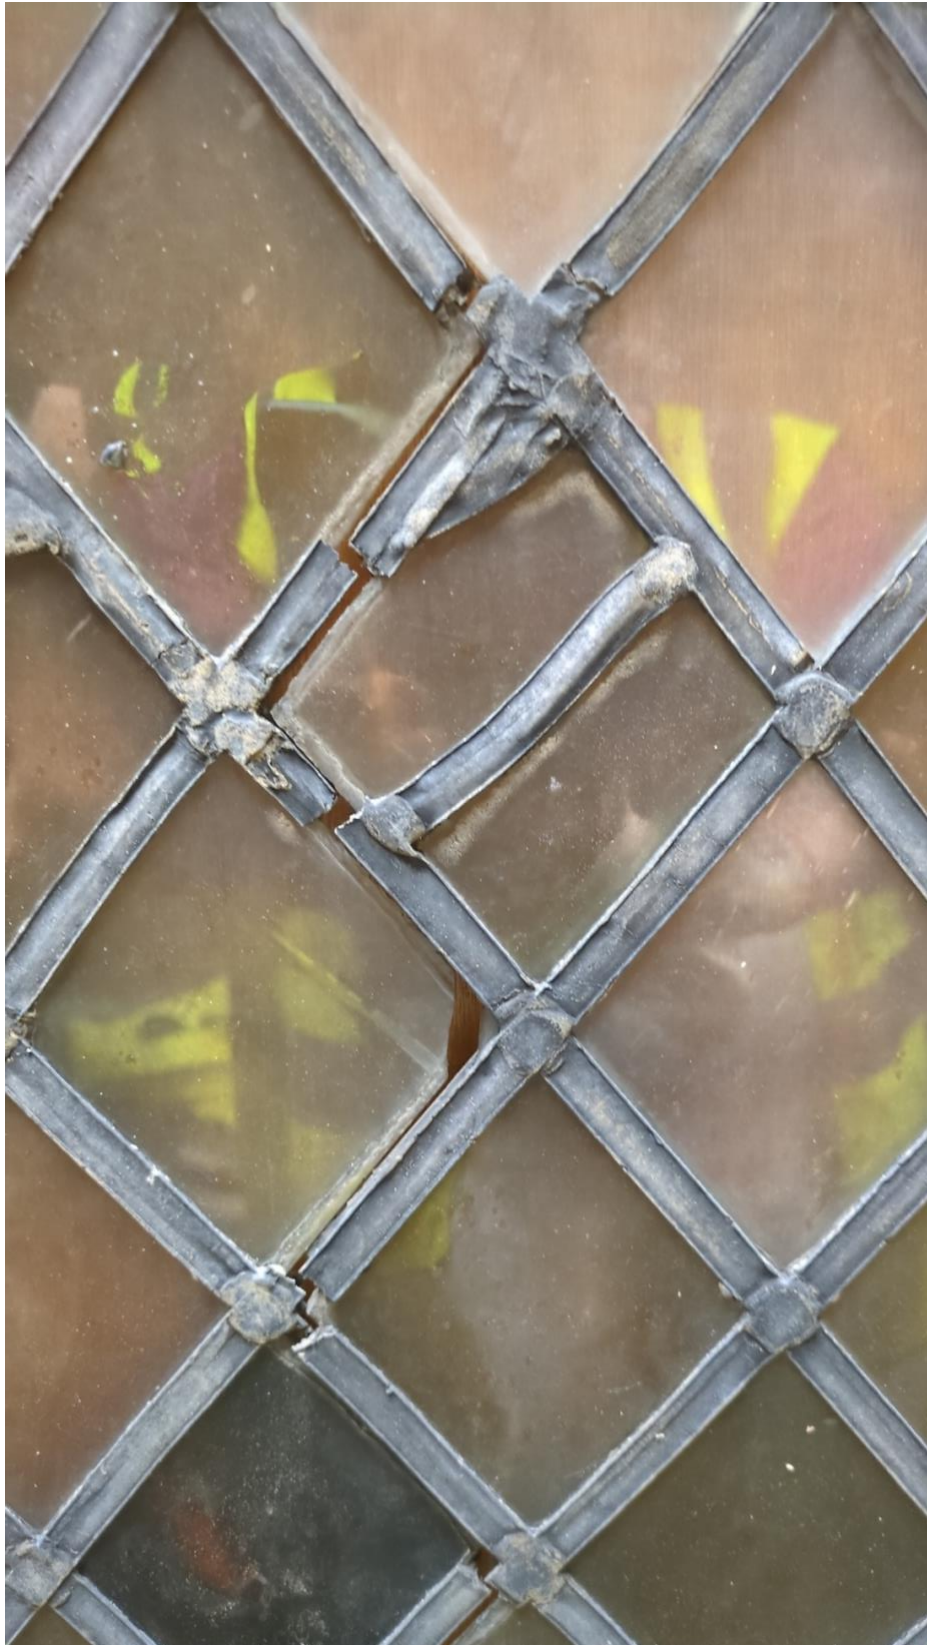
In summary, the condition of all three windows has been found to be far more serious than anticipated and from the outset, the challenges of removing panel from site safely began to ring alarm bells, as panels were found to be close to structural failure. In particular, the largest panels of all, in the two outer lancets (s20 and s22) are suffering from catastrophic failure of the supporting lead net (Figs. 3 and 4).

Fig. 3: Broken Solder Joints, s20

The inescapable consequence of the unanticipated structural failure of windows s20 and s22 is that complete re-leading of both lancets will be necessary if we are to secure and safeguard the medieval glass. The process will be conducted basically on a like for like basis with no reordering of the glass, other than the removal of potentially damaging backing plates. However, the opportunity will be taken to introduce reinforcing steels to the heart of some of the leads in order to give the panels greater strength. It is not envisaged that window s21 will require re-leading.

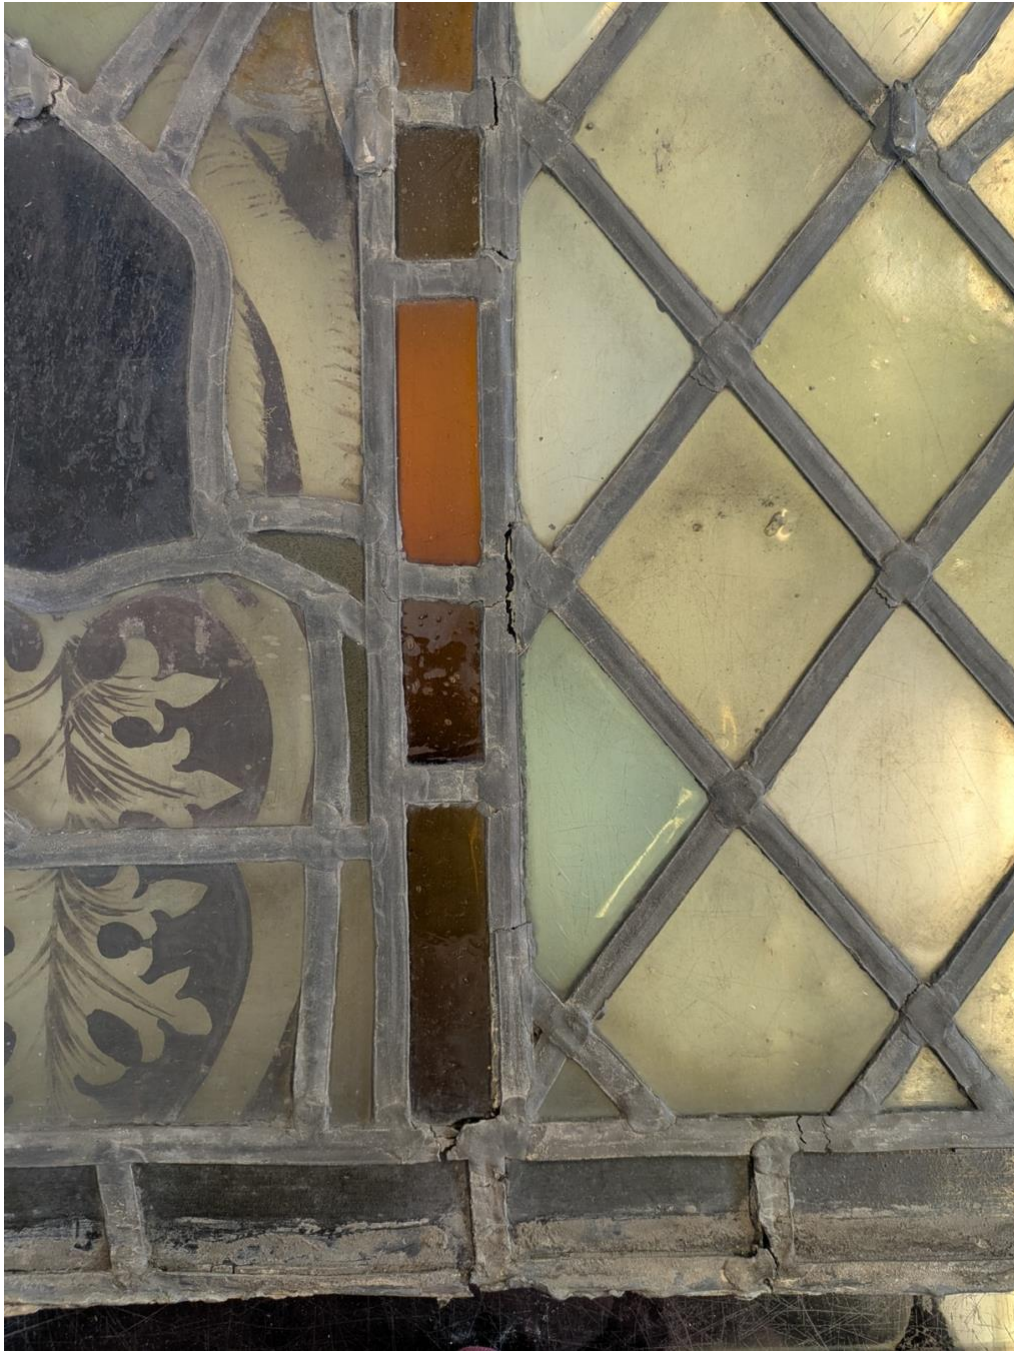
Fig.4: Failed solder joints, s20

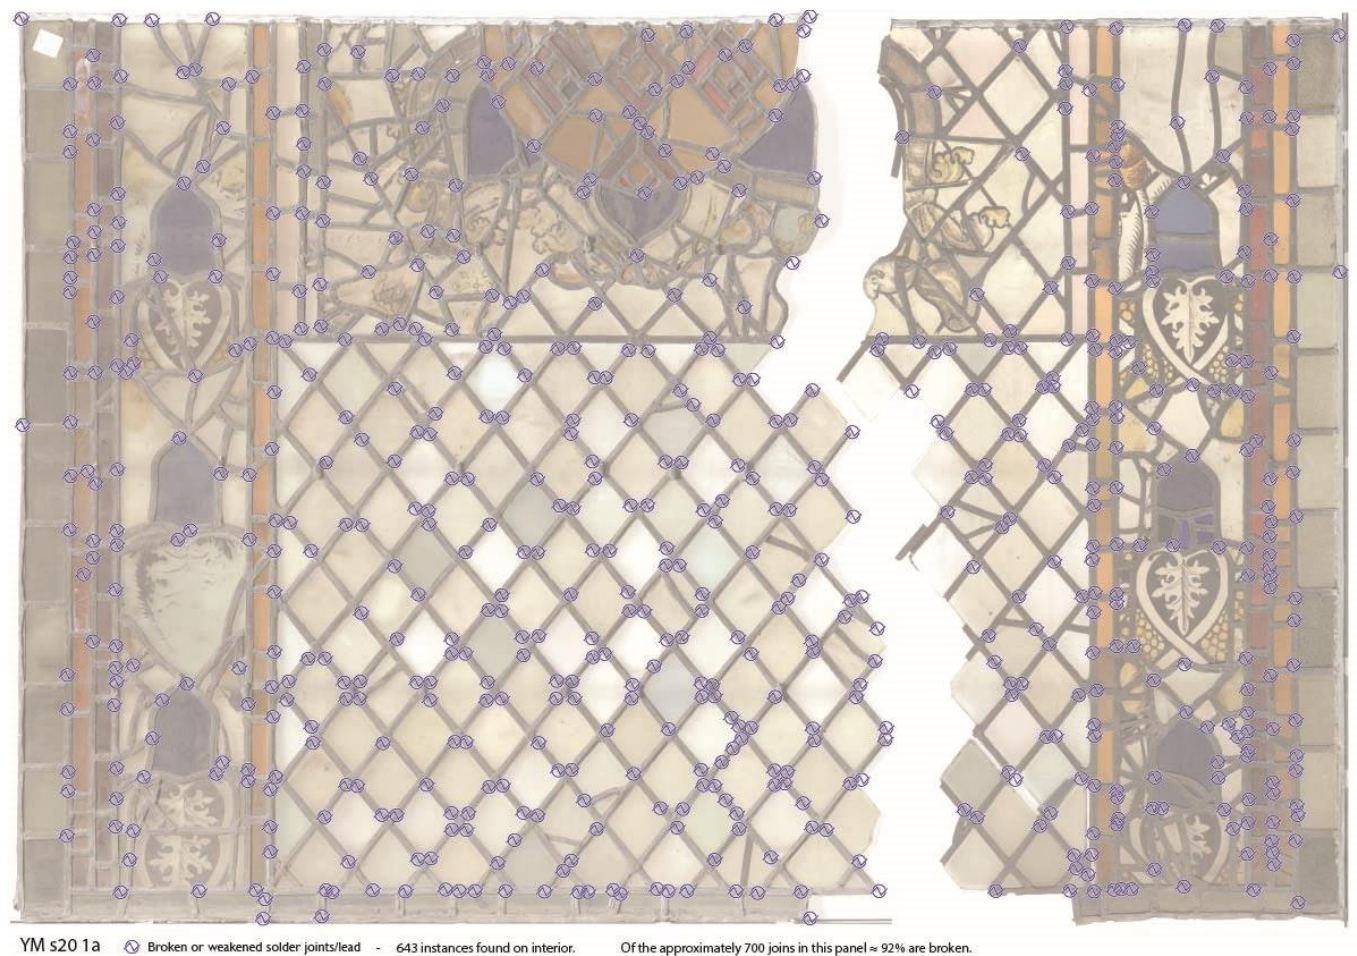
Detailed studio mapping of failed and torn solder joints in s20, based on examination of panel 1a, shows the full extent of the emergency, revealing that 92% of the solder joints have failed (ie 643 out of a total of 700). To put this in context, the nave aisle window conserved 2017-2019 required repairs to 100-200 solder joints. That the panels have not already begun to buckle and collapse is remarkable, and the decision to scaffold the south transept at this

Fig. 5: Studio mapping of failed solder joints (s20, 1a)
