Section 8 of Care of Cathedrals Measure 2011 Public Notice on application to the Fabric Advisory Committee

Conservation of an oak armchair with brown suede upholstery bearing a decorative roundel with cross keys pertinent to the cathedral (Inventory no. YORDC/2015/14), to allow it to be retained in use in services in York Minster.

LEATHER CONSERVATION CENTRE

CONDITION REPORT

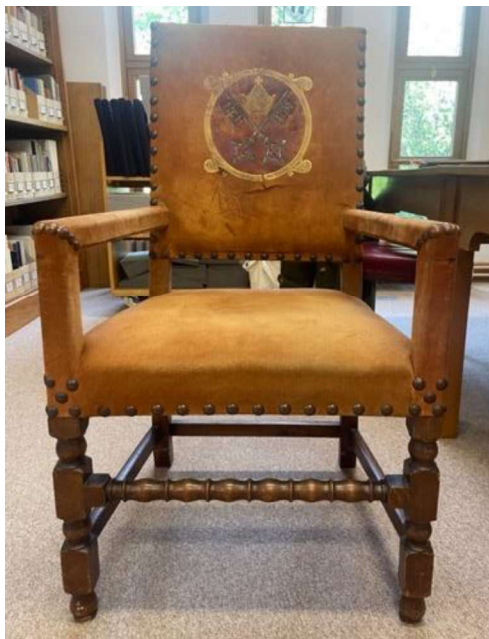
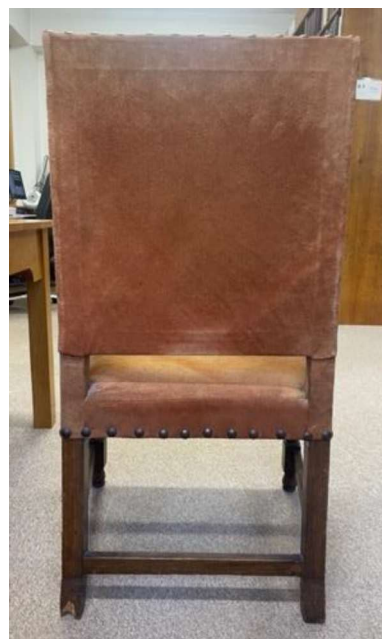
Object Information: Oak armchair upholstered with brown suede leather

With the exception of the seat back, the chair appears to be in a relatively good, stable condition. There is ingrained dust across the fibrous leather surfaces, particularly concentrated in crevices and at corners at the back of the chair.

There are three prominent splits in the central region of the seat back which are likely the combined result of pressure applied during use and natural shrinkage of the leather in response to dry environmental conditions. The two larger splits correspond partially to areas of decoration indicating the collagen structure is slightly weaker where the fibres have been compressed during the moulding process. This theory is supported by several tears and observed points of weakness around the edges where the same leather is in contact with dome headed nails.

The proper right split measures approximately 6cm in length and is located in the lower PR corner of the design. There has been a small area of loss and some movement of the leather meaning the split edges don't fully meet; the leather retains flexibly but due to the compression and application of materials to create the 'gilt' decoration, it isn't as flexible as non-decorative areas. This is the case for all split.

The second, smallest split is approximately 2cm in length, located perpendicularly through the gilt circular frame towards the bottom. The split edges don't comfortably meet due to shrinkage of the leather.

The third, largest split appears as an upside-down 'T' formation, the lower horizontal line measuring approx.. 8cm and the vertical measuring approx.. 4cm which penetrate across the 'gilt' frame into the red central area of decoration. The lower, horizontal split extends through non-decorated leather. As with the other two

splits, edges don't comfortably meet due to shrinkage of the leather and there is less flexibility at areas of compression.

There are 7 small splits in various locations across the keys that are either fully or partially formed. Several of these align with points of decoration and at present edges meet flush. Several additional areas within the decoration appear vulnerable to splitting in the future without additional support.

There are several splits in the leather along the edges of the PR edge of the chair back and where pressure has been applied by the top couple of dome-headed nails. No other splits around nails are observed but it is likely that the leather in these areas is weakened and vulnerable to future splitting.

There are two small areas of loss on the wooden legs: one at the bottom of the front PR and a slightly larger one on the back PL. Neither are compromising stability, and all other structural components present as stable.

- Surface clean all surfaces using dry techniques to remove dust and engrained deposits. Dry cleaning will be carried out with brushes and a vacuum. No additional cleaning will be carried out on the silver leaf.
- Remove dome-headed nails and staples (if possible) around edge of seat back to detach leather allowing access to the grain surface. If staples can't be removed due to poor access, the leather will be split along the edges.
- Fully line the leather with a non-woven fabric applied to the grain surface to provide overall support and strength. This choice of material will depend on the strength required and the choice of adhesive, but the most likely candidates are Cerex or Reemay.

- Reattach leather to wooden structure using original nails and supplementing with adhesive where necessary.
- Fill the small area of loss and provide additional support as needed to the front of split areas to ensure edges don't catch when in use and visually integrate.
- Carry out tests to better understand the composition and stability of the red pigment and consolidate if deemed appropriate.
- Document and write report of treatment including recommendations on use and long-term case.
