The Cathedral and Metropolitical Church of St Peter in York

Design & Heritage Report for CCM Application

Revision A04 February 2026

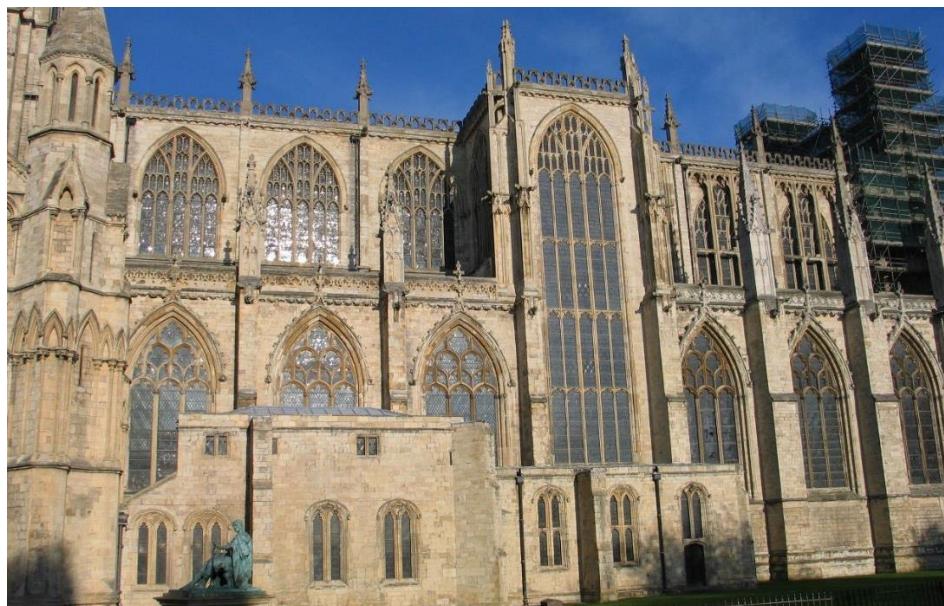
The South Quire Elevation in 2015 – which has been shrouded in scaffolding now to 10 years. Few members will recall the elevation without scaffolding.

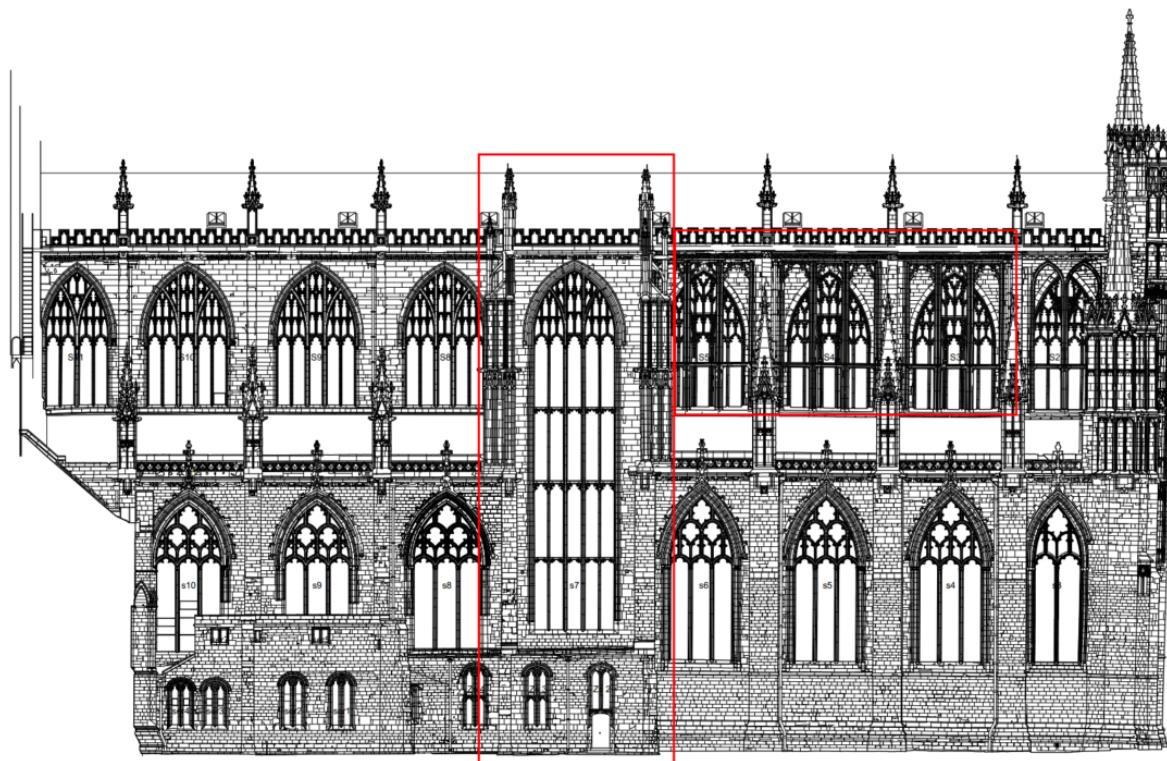
SQA elevation outlining the extents of the CCM for which approval is sought to Area 2 and Area 5, as per the working areas defined in 2015 by Andrew Arrol. Note that Area 2 includes the side>Returns and windows S6 and S7 on the east and west faces of the transeptal bay.

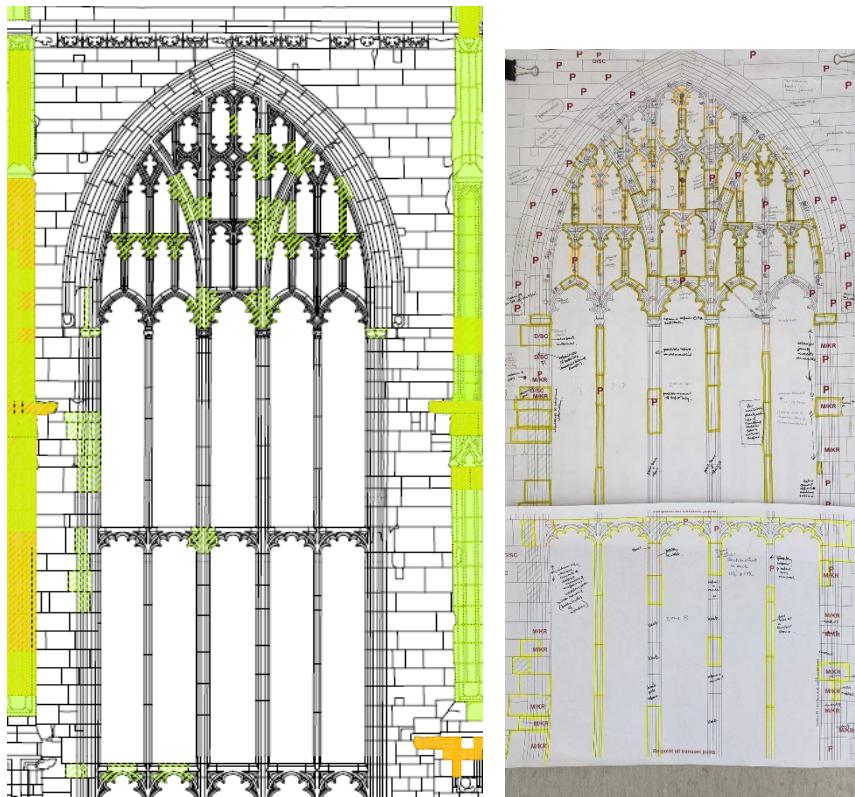
*Approximate side by side comparison to same scale (NTS) from our initial 2024 findings:
 On Right, stones outlined in yellow were subsequently scheduled for replacement. Stones highlighted orange are provisionally scheduled. These orange stones would be templated for renewal and, once dismantled, the final decision on replacement would be made. The basis for this consultation and CCM application has now further developed based on new research and we are seeking an approval for even more extensive renewals of stonework.*

As can be seen in the illustrations above only a limited number of stones for renewal in the upper tracery were identified in 2018. As has been ingeniously achieved on other windows, the expectation was that much of the tracery stonework could be retained in situ and temporarily supported whilst these stones were removed, re carved and re fixed.

Comparing this with the work in progress survey drawing on the right, it is immediately clear that there is considerably more replacement stone required. This partly comes from the opportunity to properly inspect all round, now that the glass has been removed and we have an internal inspection scaffolding. We made the somewhat unexpected discovery that the condition of the tracery stonework *internally* is markedly poorer than we typically encounter. There are a combination of decay mechanisms and weathering, both internally and externally, including fractures which run from inside to out, which could not be seen before the glass was removed, whilst large areas of the internal stone face had been coated in hard mortar repairs. Cracks have since been pointed and tell-tales added and monitored, and a continuing strand of investigation seeks to further understand the cause of accelerated decay seen on the internal stones. Stephen Parry of the British Geological Survey has been engaged to advise on stone testing, both in this respect and for validating suitable stone selection for repairs. Dr Parry has also given a preliminary view of the decay mechanisms which theorizes a cause for the relatively poor condition of the window tracery and stonework.

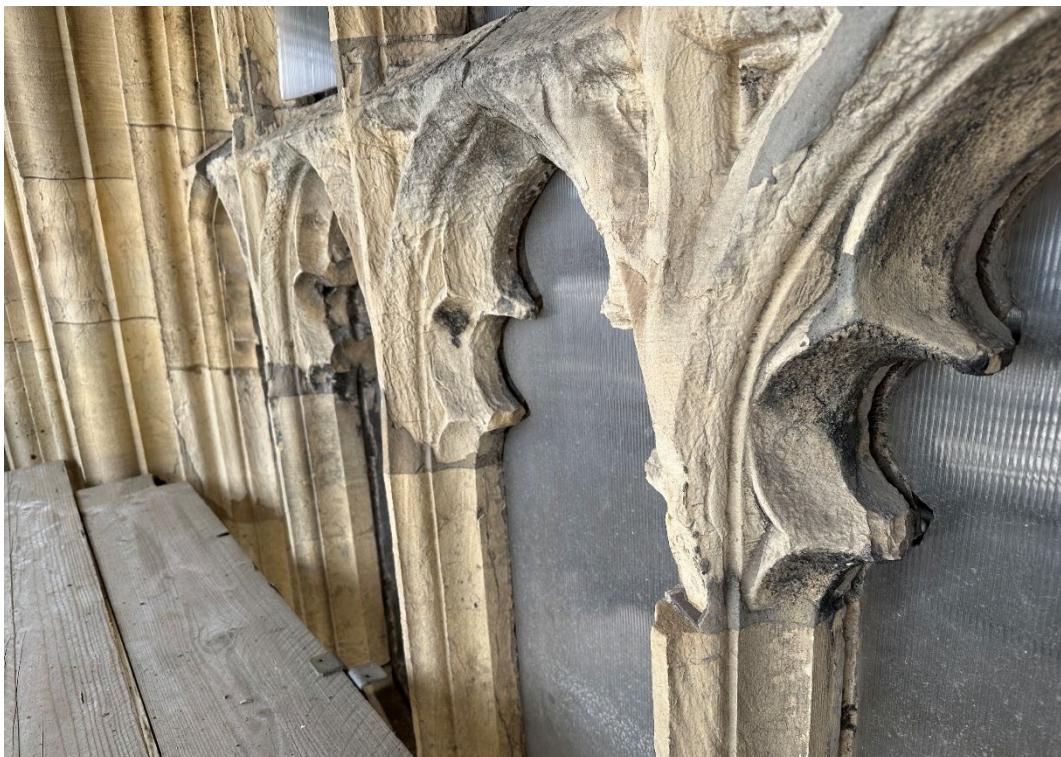
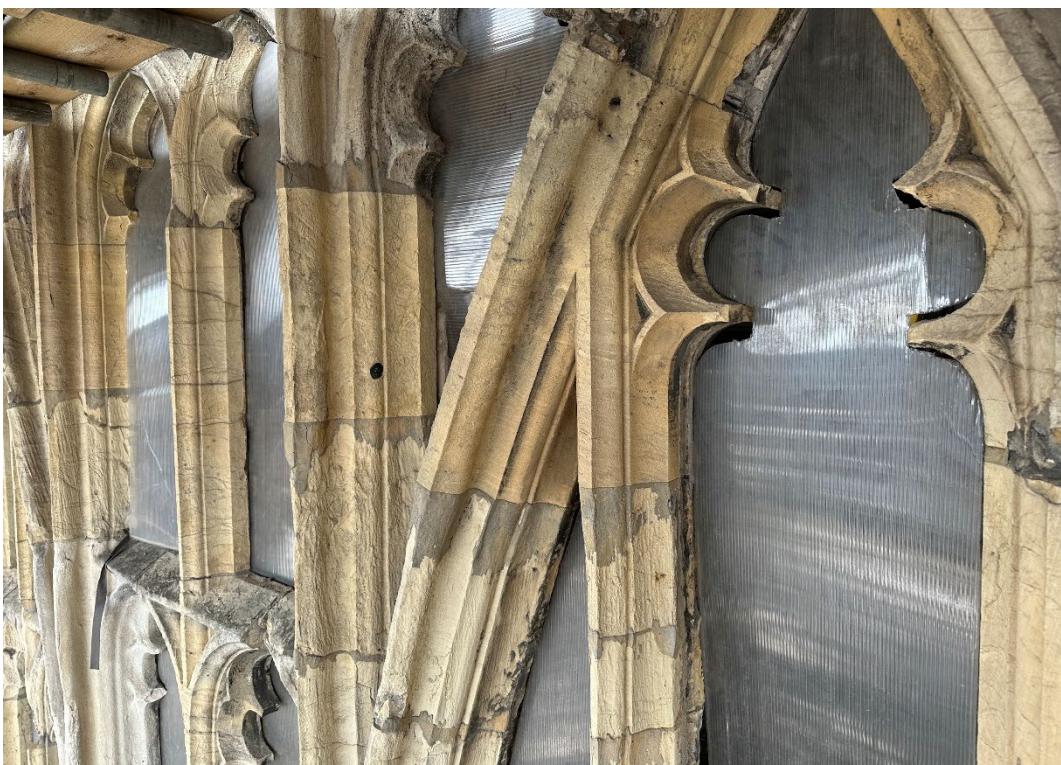
Deterioration of earlier magnesian limestone components with significant renewal in the 19th century. Note the profiling discrepancies between the two phases of work, and the application of hard cementitious mortars to infill spalled sections and blend the two together. This not only has a deleterious impact on the adjacent stone but creates a maintenance and safety issue as the mortar repair begins to detach.

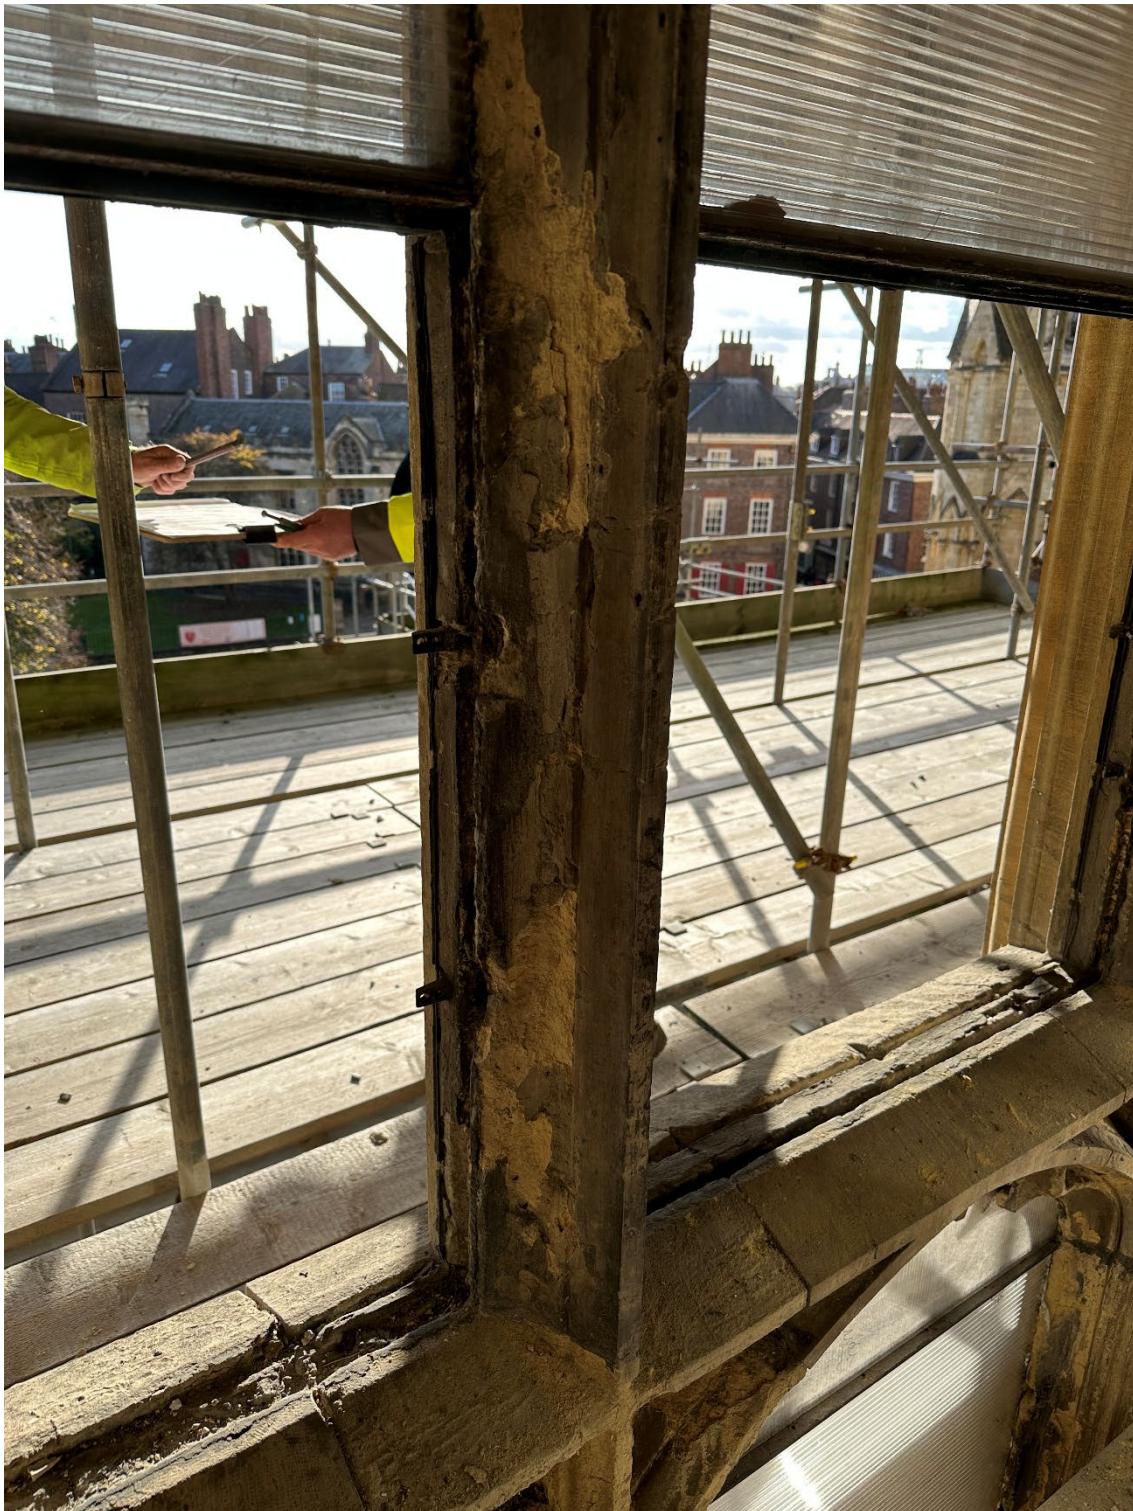
Example of deterioration within internal stonework.

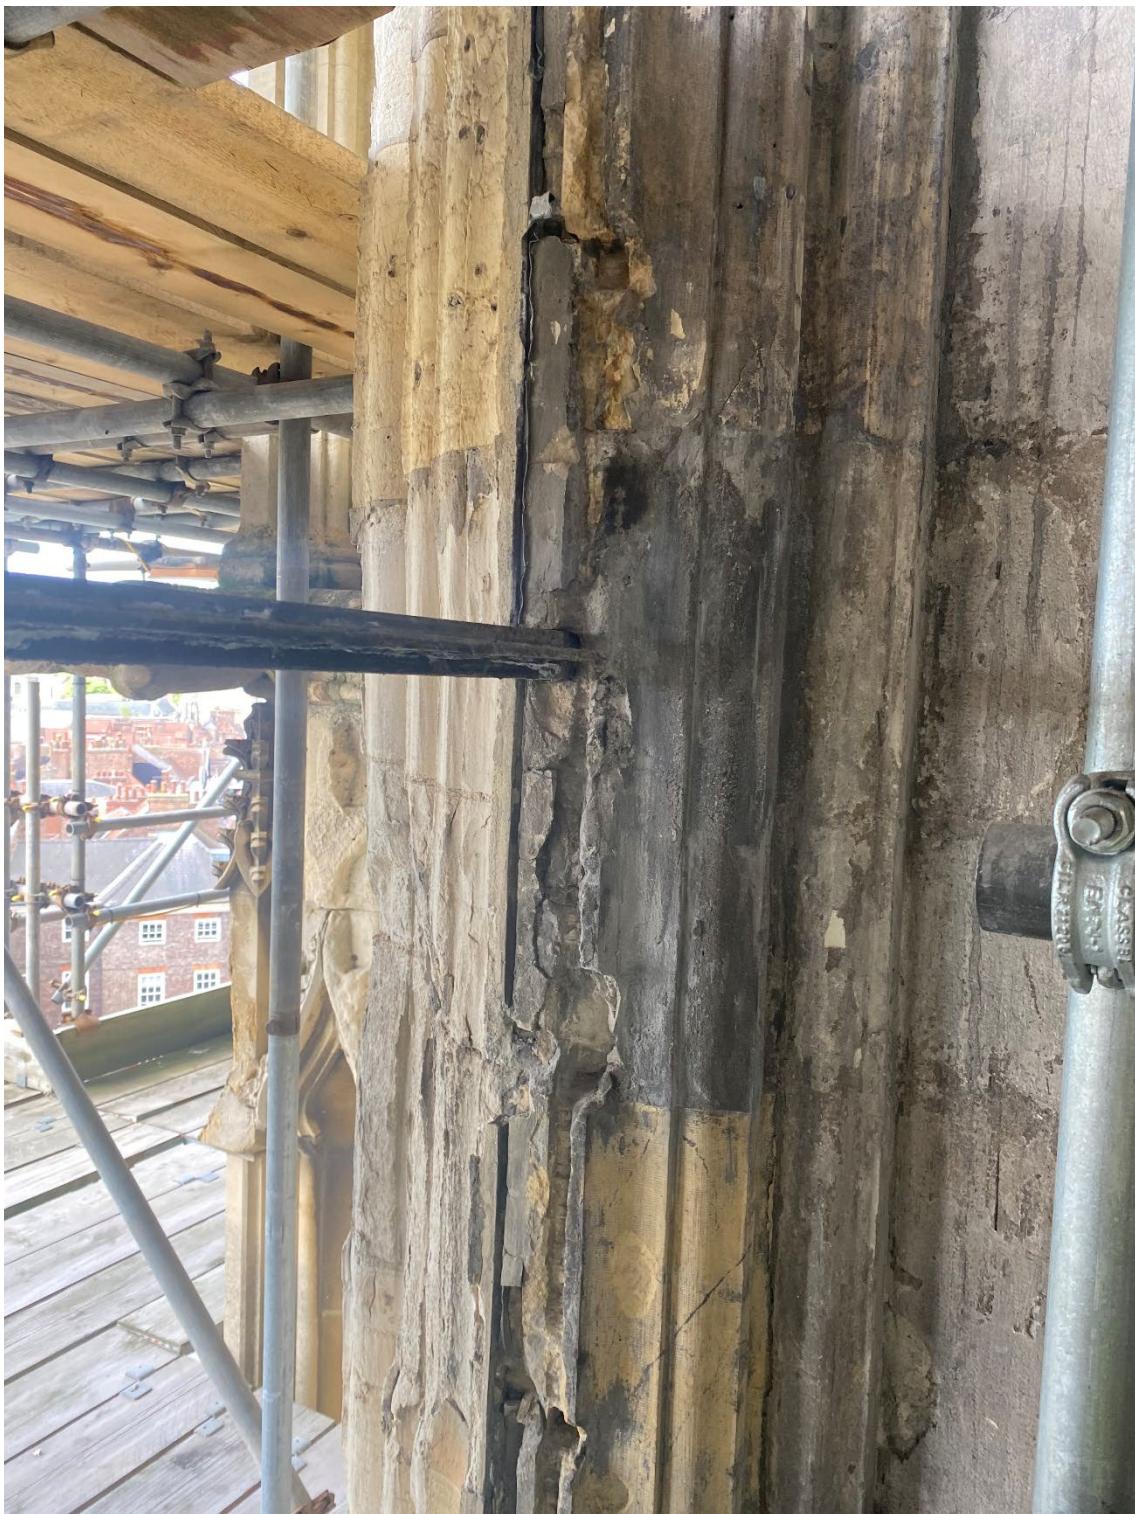
Damage to the stonework along the glass line and the very extensive cementitious 'repairs.'

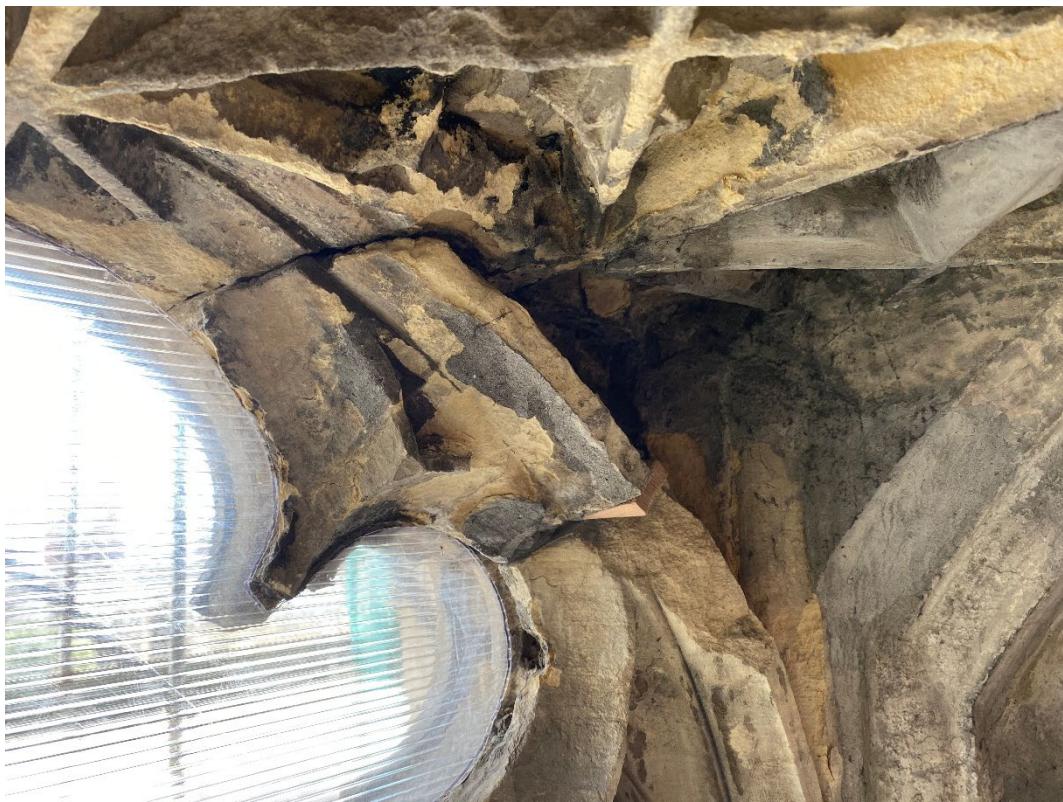
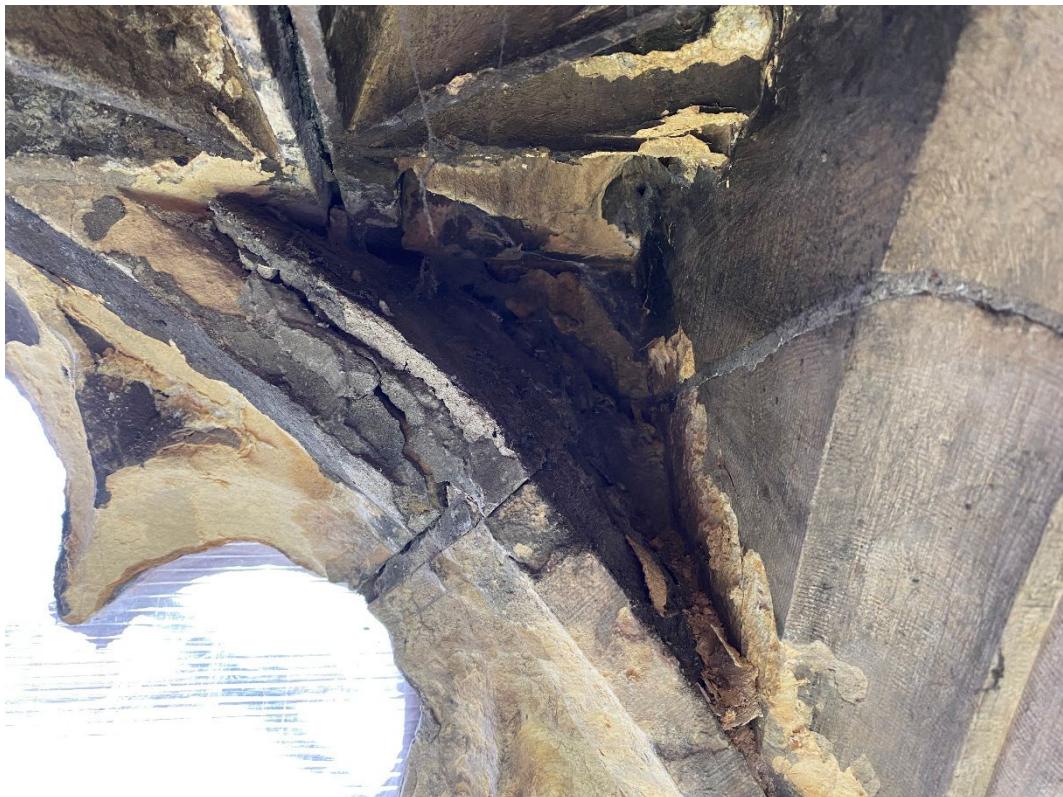
Fractured, spalling and friable stonework internally, again creating a safety issue by presence of loose and detaching fragments.

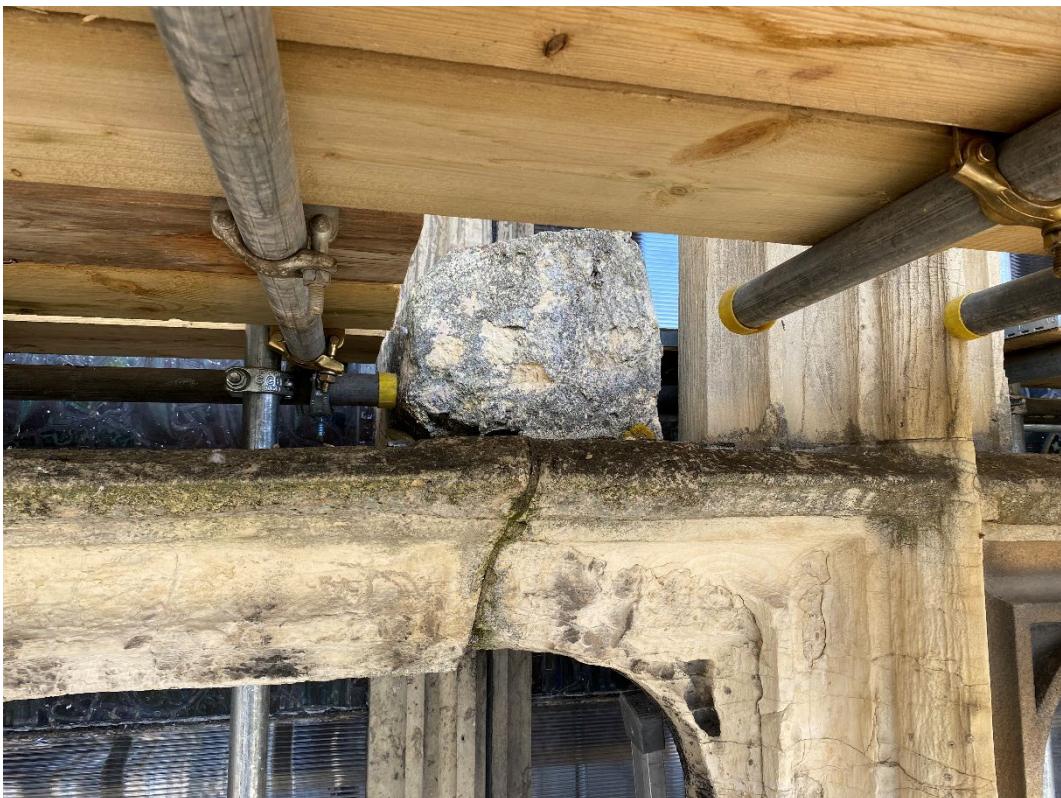
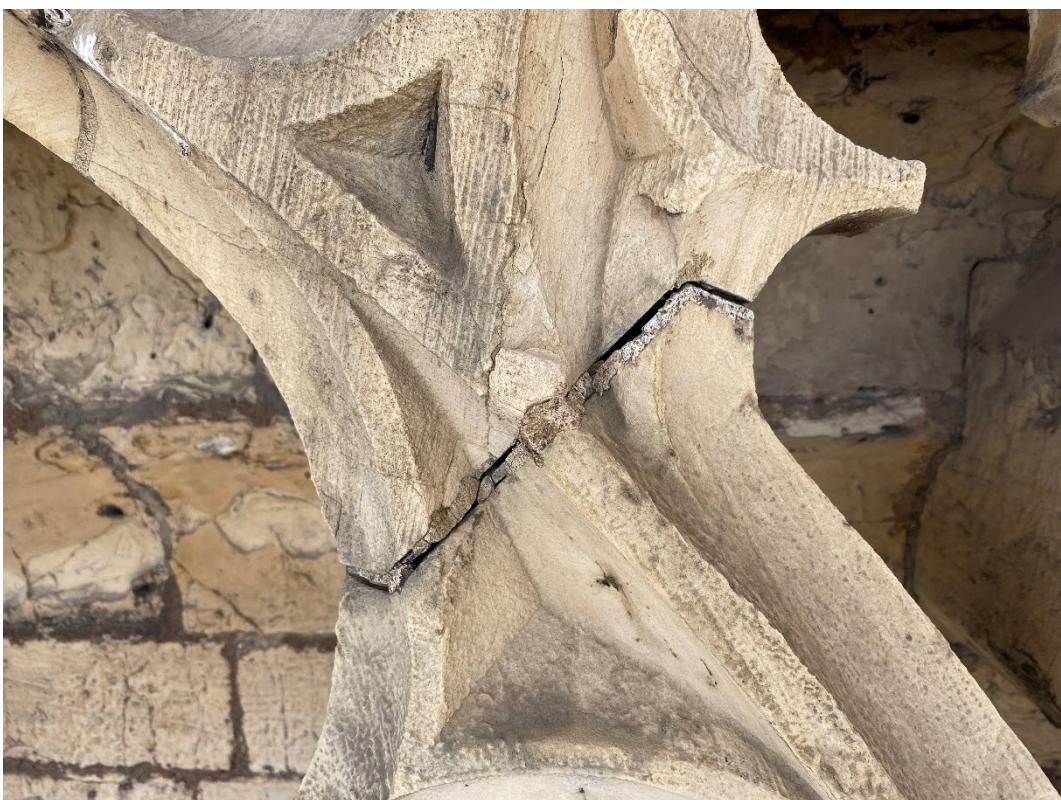
Evidence of structural movement within the masonry due to rust jacking.

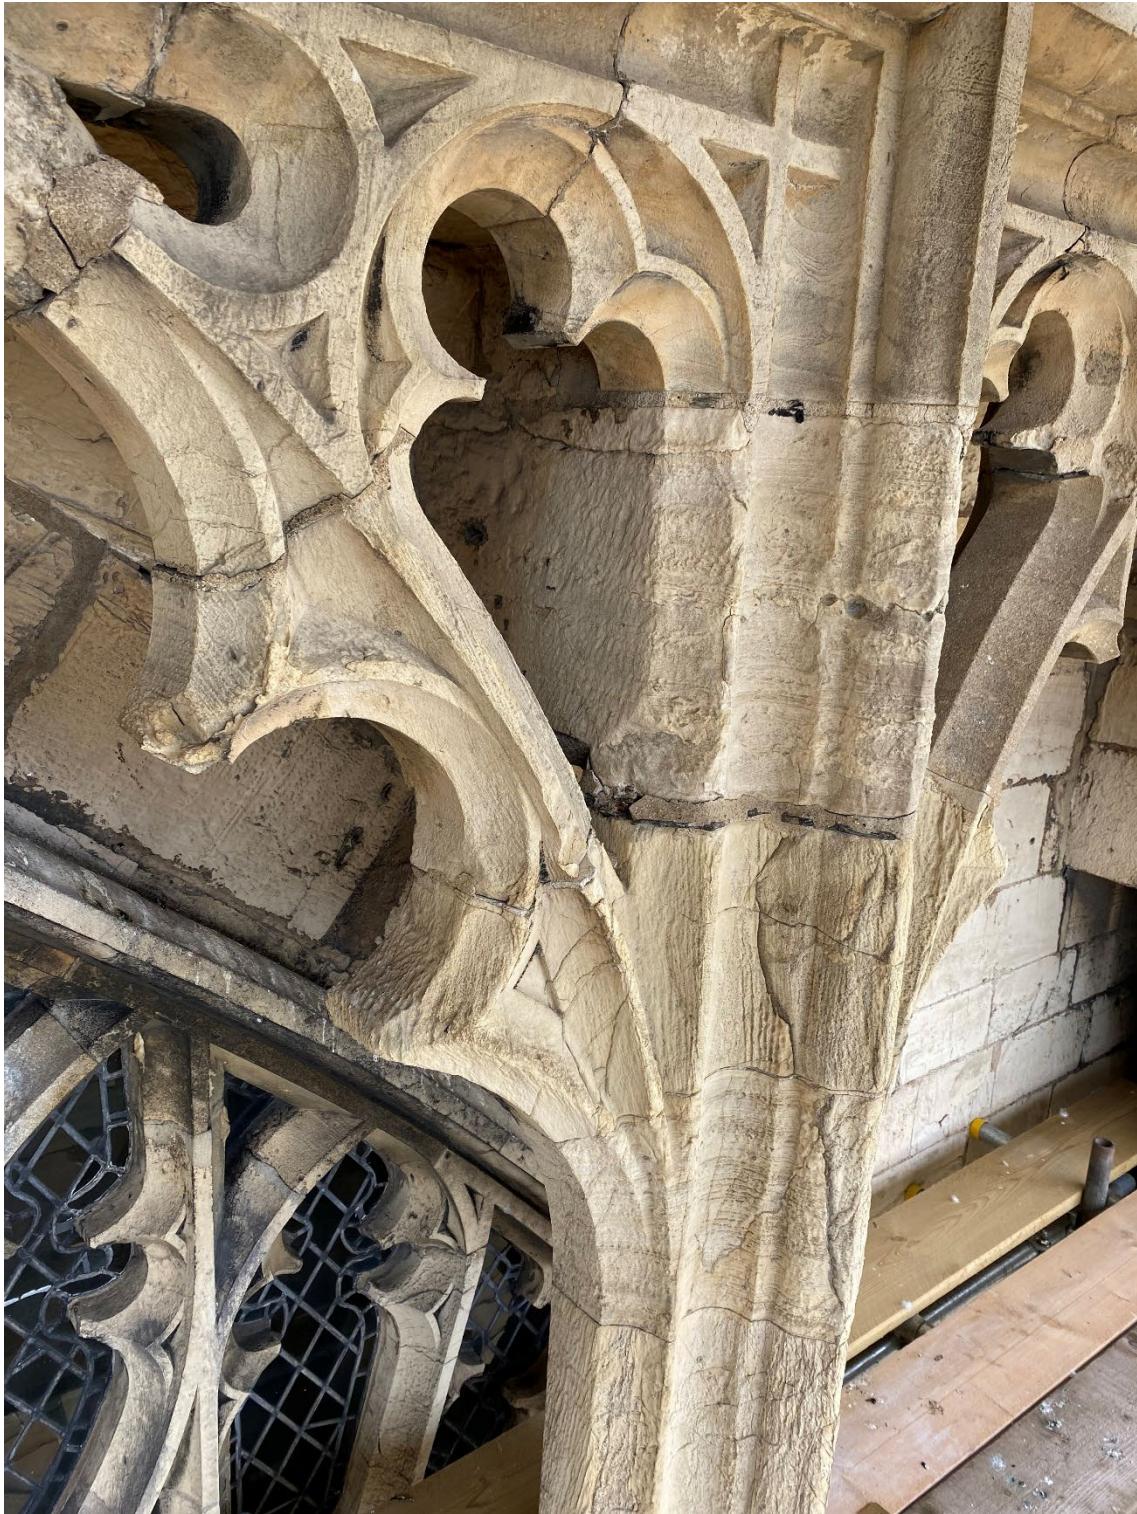
Cracked and spalling stones – note the enlarged bed joints which conceal rusting iron.

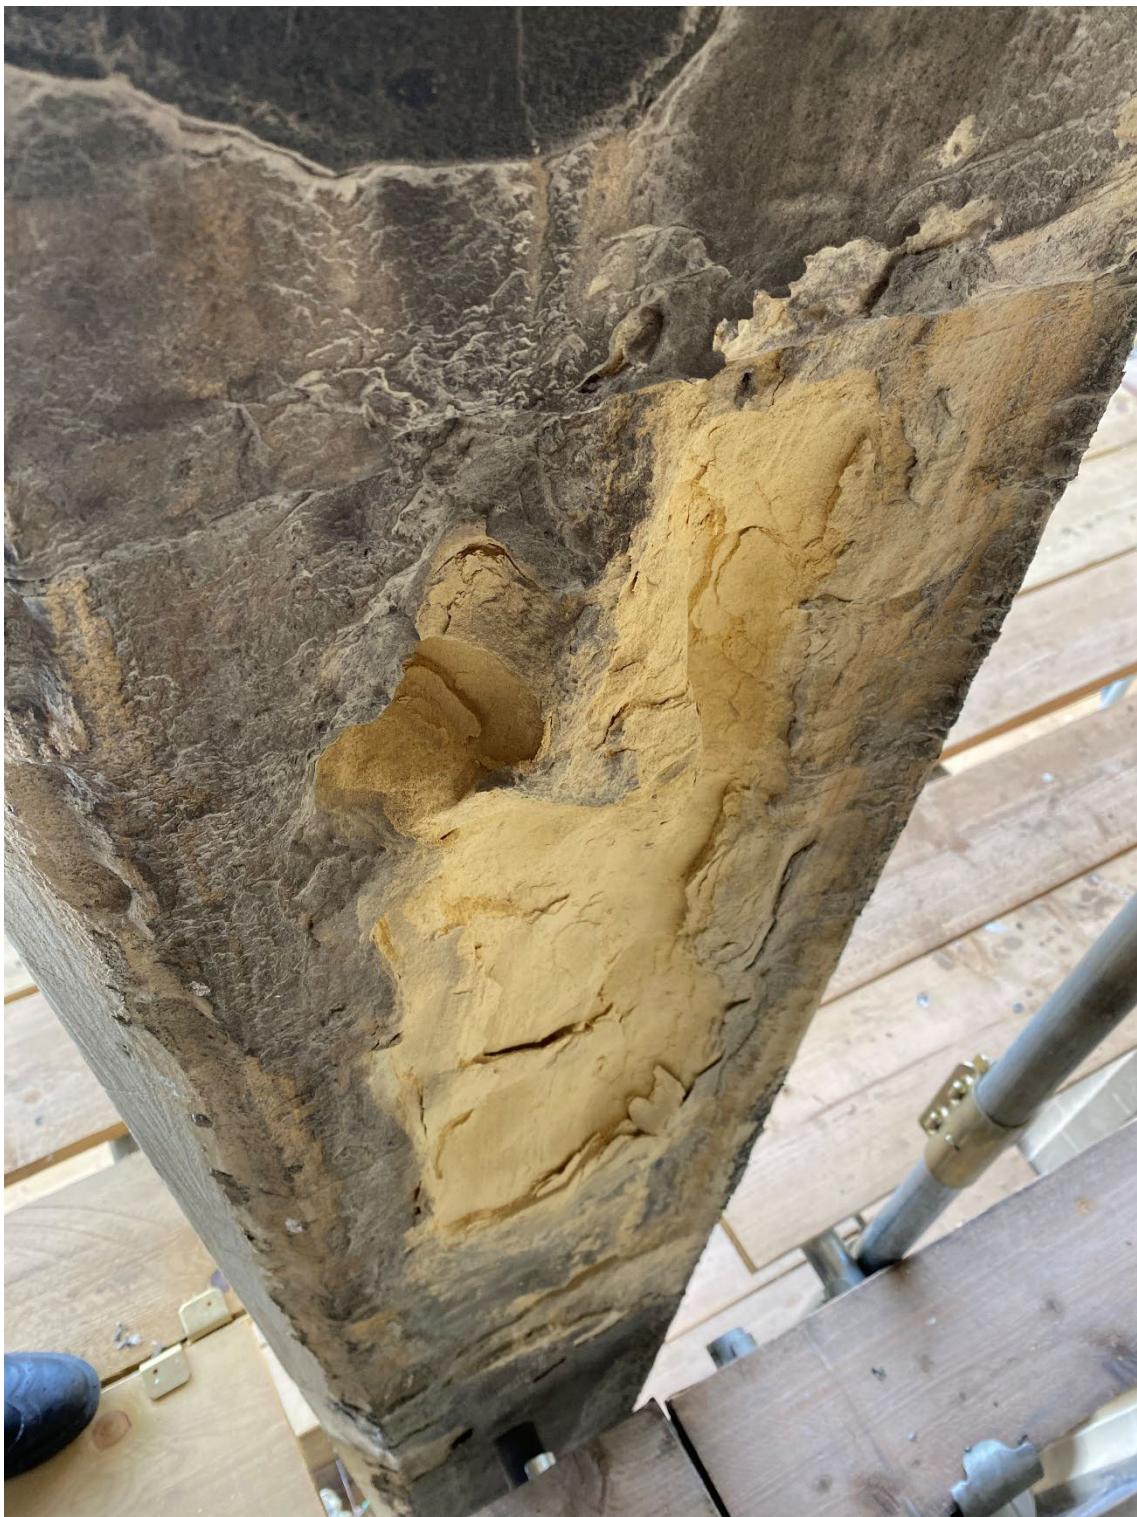
Preferential decay of softer units in the primary skeleton structure.

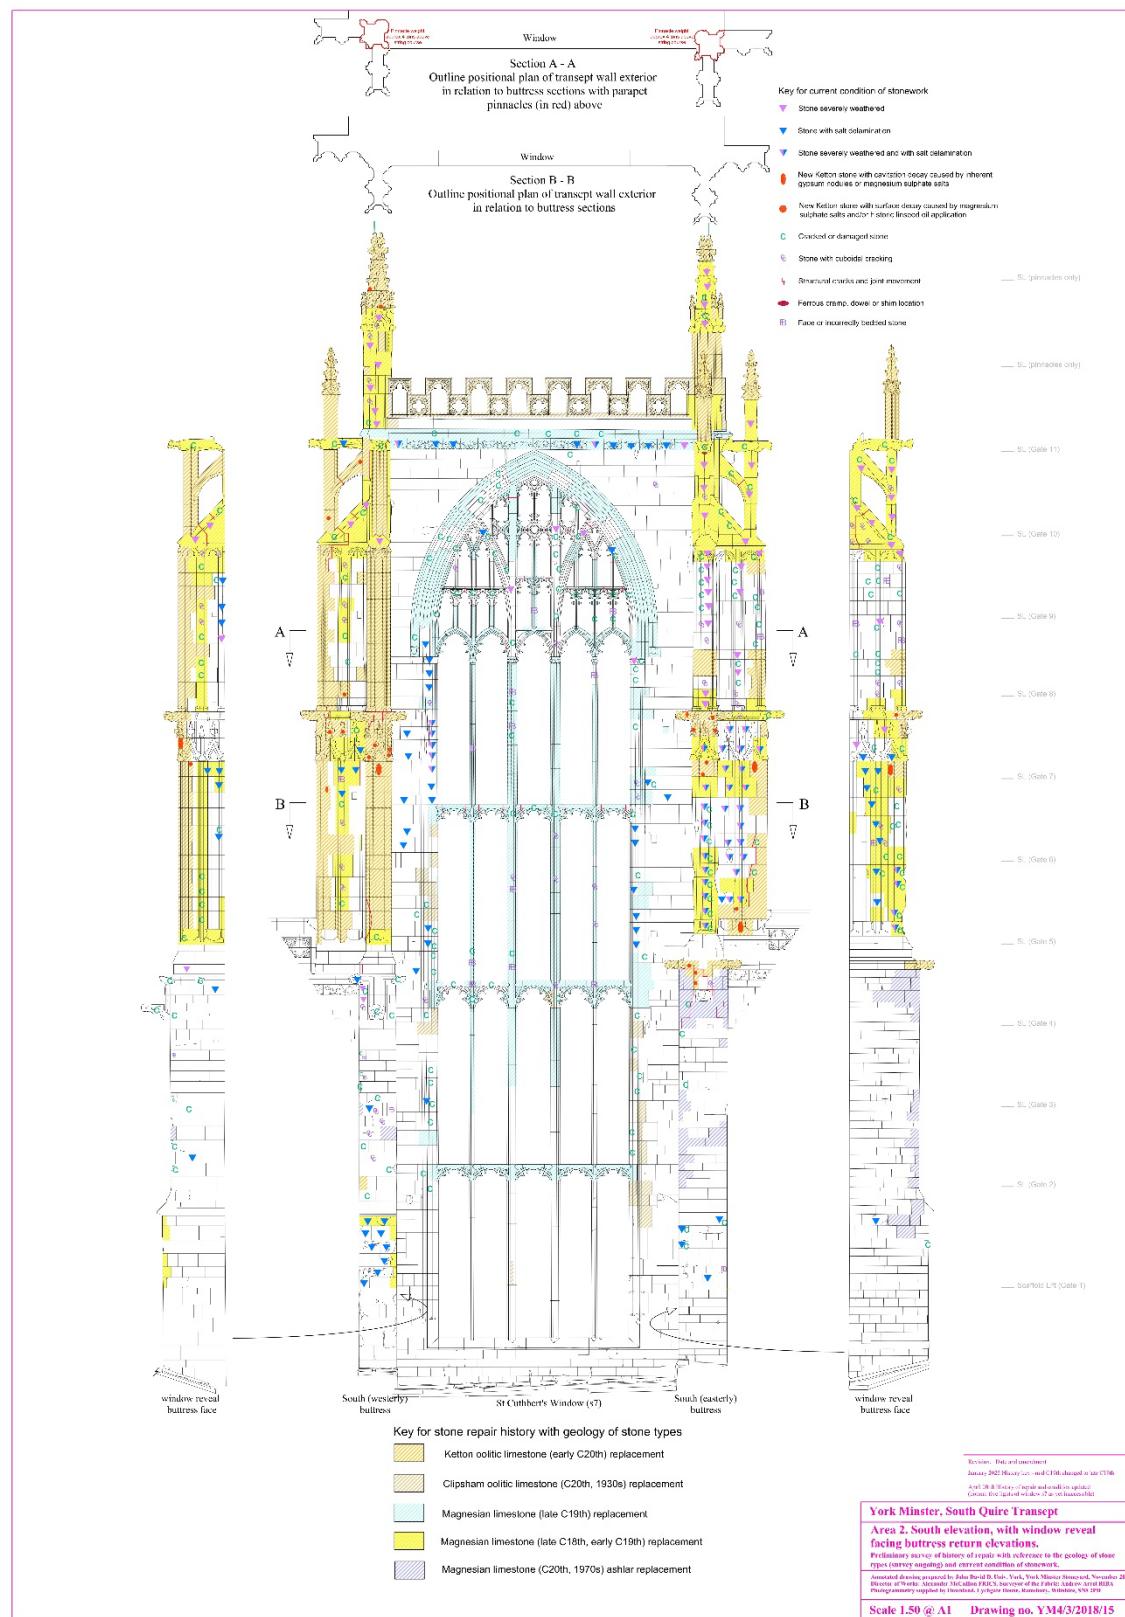
Area 2 (SQT), South Elevation with window reveal facing buttress return elevations: History of repair with reference to geology of stone types and current condition of stonework (Work in Progress)

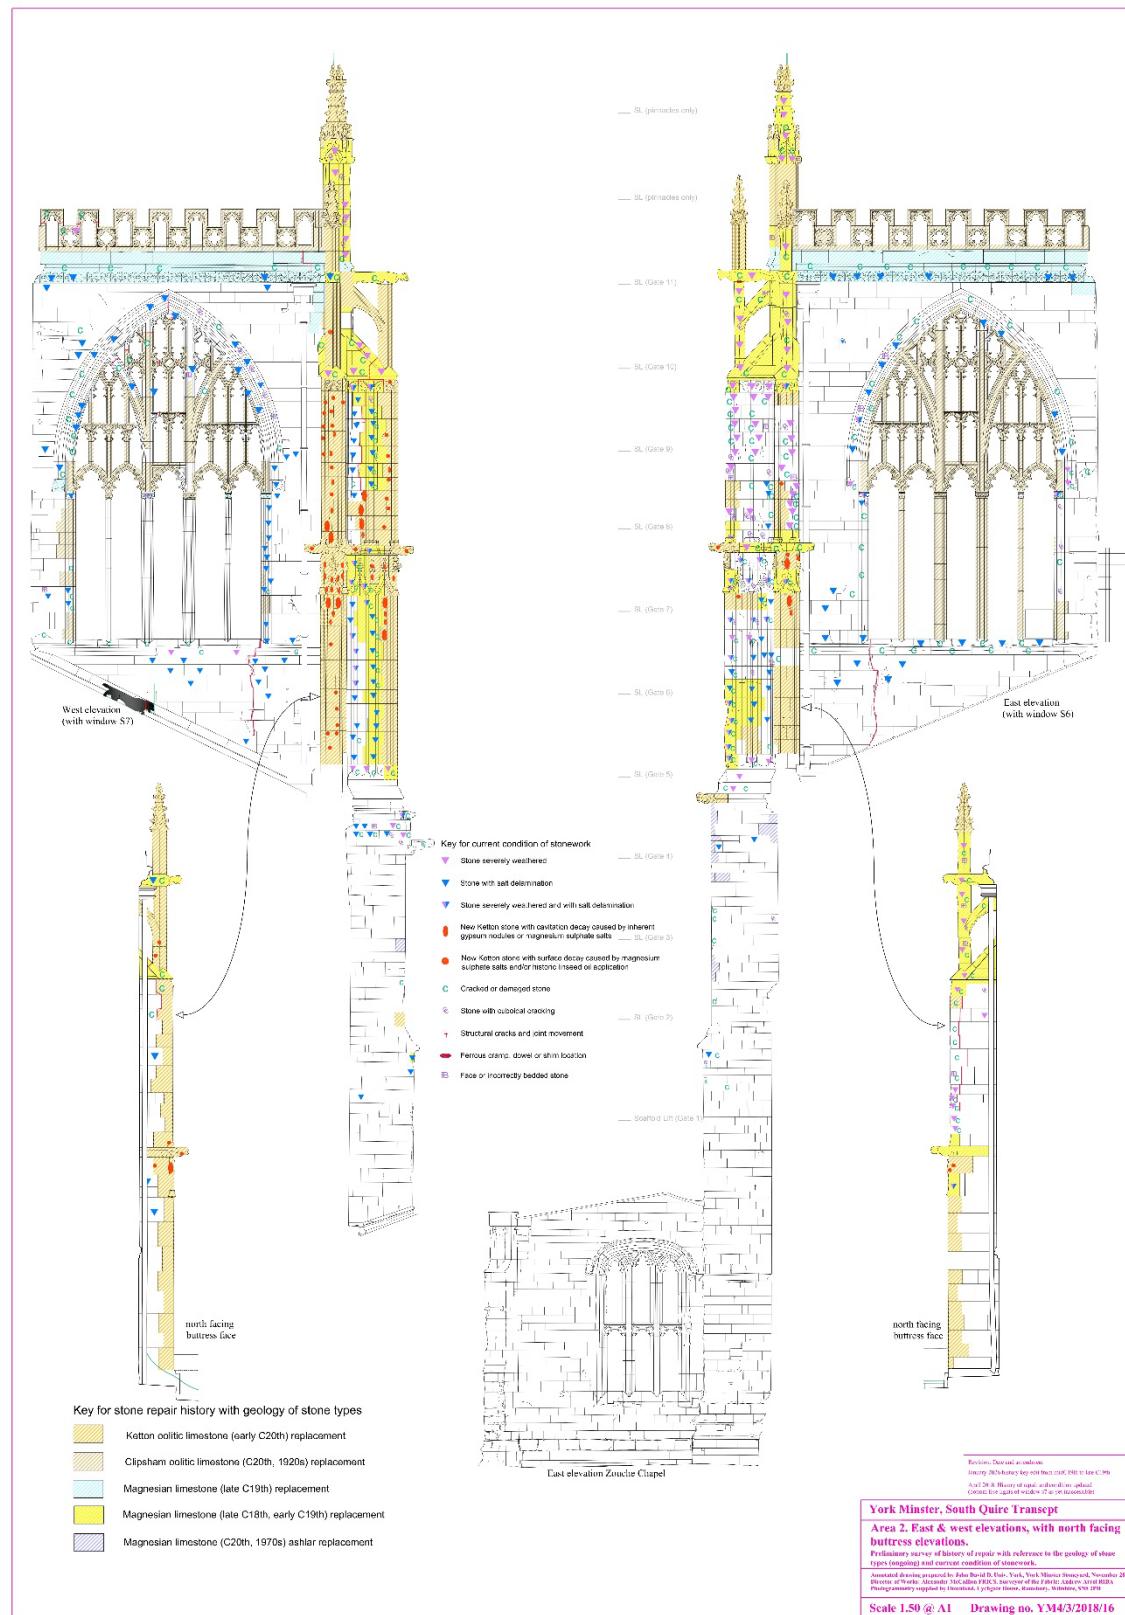
Area 2 (SQT), West and East Elevations with north facing buttress elevations: History of repair with reference to geology of stone types and current condition of stonework.

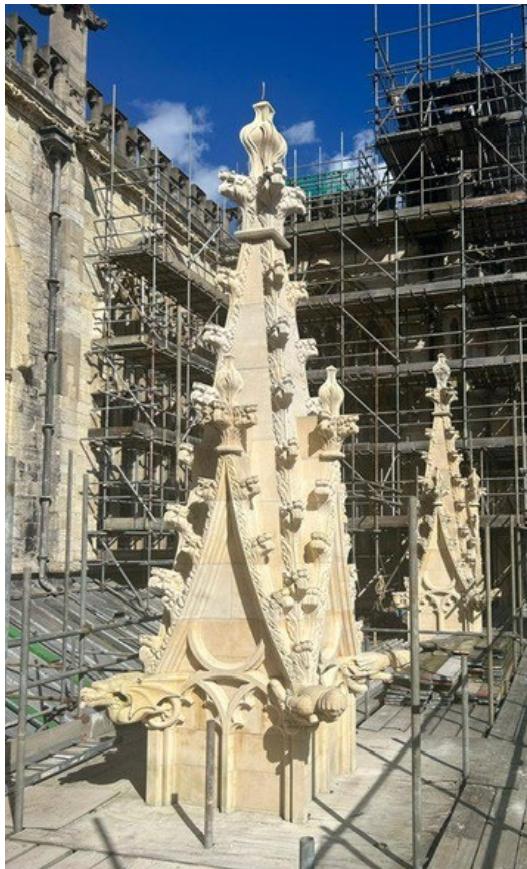
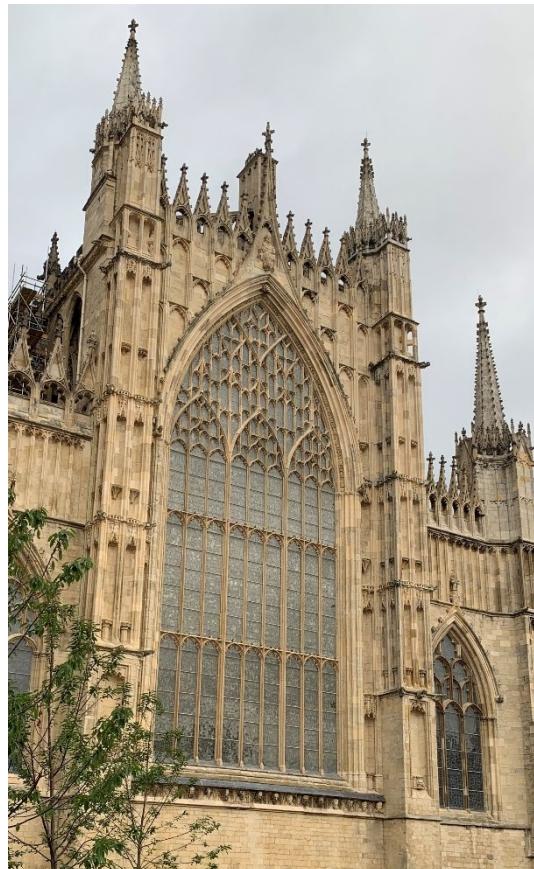
Left: Photograph showing completed pinnacle repairs incorporating a mixture of Cadeby and Highmoor stones. Right: Photograph showing precedent use of Lepine

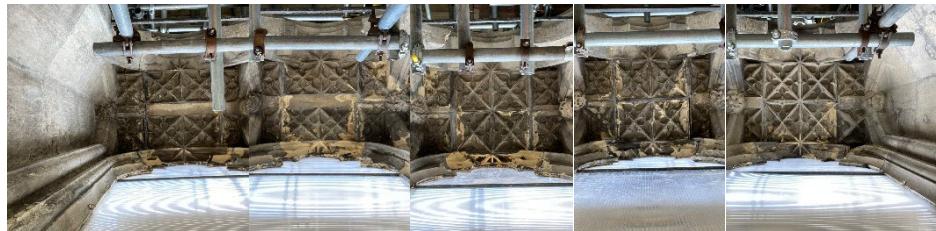
Collage of the bridge structure looking upwards.

There are fractures to the outer tracery stones: two need replacing. There is also a range of conservative repair required. We are studying the assumed construction sequence to better understand how renewal of these locked-in stones would be undertaken. Our concern is to hold this stonework in situ whilst there are still components that will need to be replaced below. There is structural tying to be reinstated across this spanning structure which appears to be parting company with the supporting walls and their buttresses. At the present time, our premise is that the bridge structure is held in situ: even whilst there are stone renewals to major structural supports beneath it externally. The internal structural screen stones are mostly in good repair, except for the structural break at the reveals. Temporary propping will be incorporated as required to facilitate replacement of these components and a number of the external mullions.

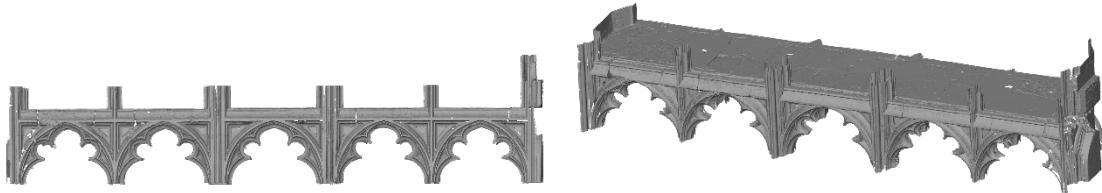
The s7 window bridge in 3D scan, onto which we can document repairs and archaeological detail.

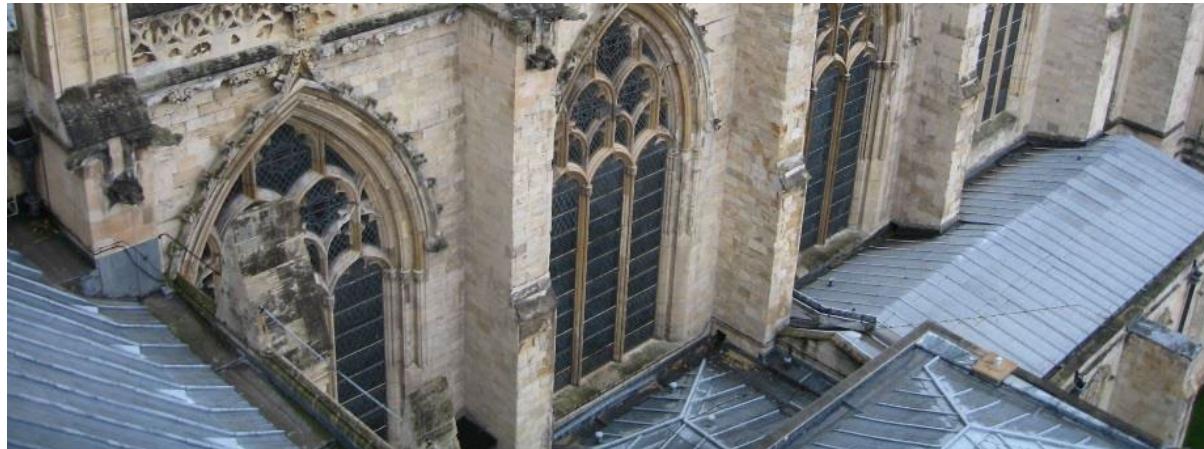
Overview of Zouche chapel roofs (from 2015 before scaffolds were erected) illustrating some of the form and complexity of the roofing configuration including the through-gutter which runs through both of the major buttresses.

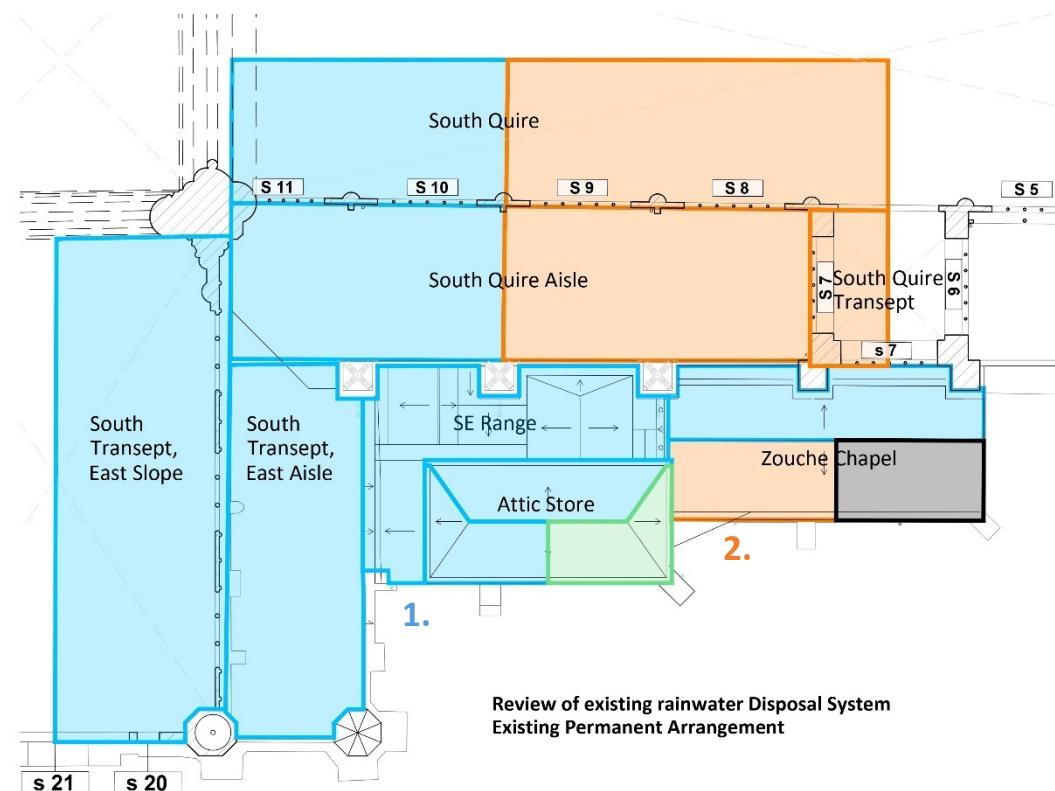
At present a temporary arrangement is in place, whereby water is transferred from the west slope of the South Quire Transept roof along a rather unsatisfactory horizontal connection to the west end of the Quire Aisle roof (avoiding the eastern sump and downpipe to the Zouche roof). The effect of this is a further increase in the loading on the existing downpipe (1) as shown below.

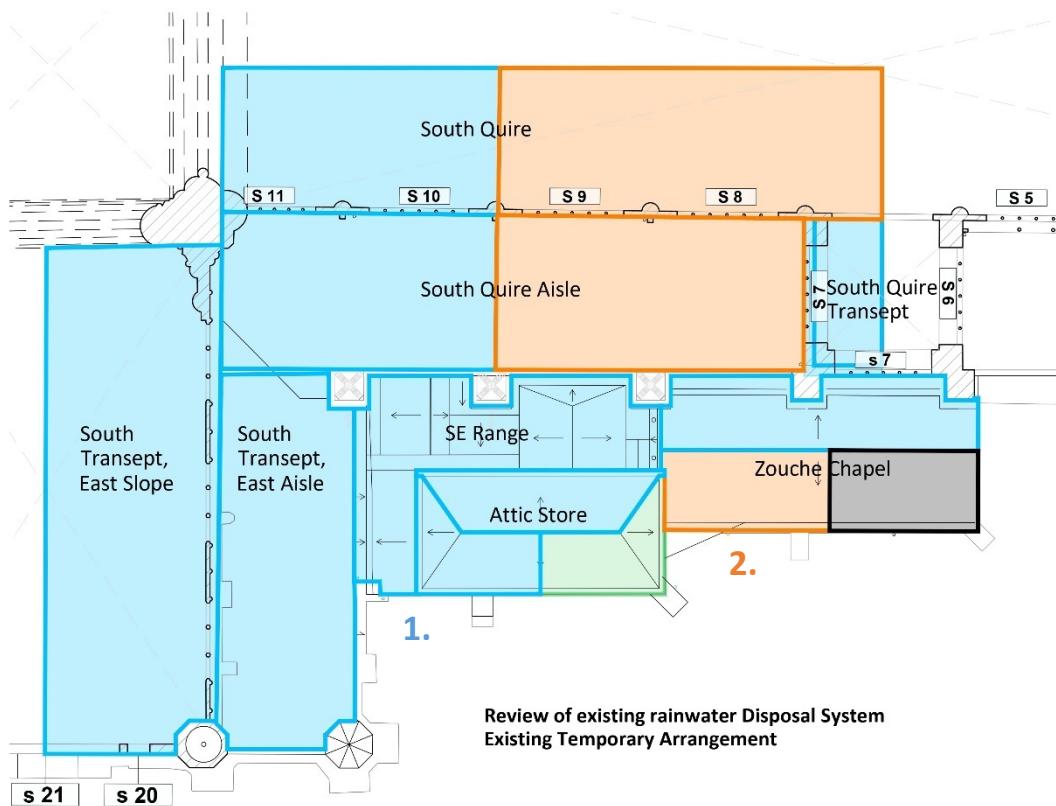
At 130mm ext dia. the existing downpipes (1 & 2) appear to be undersized to cope with the expected volumes of water. Ideally, additional downpipes would be devised to share the load although given the layout of abutting structures, opportunities are limited. One potential means of mitigation would appear to be the introduction of a new downpipe to the South Transept, East Aisle. With reconfiguration of the associated gutter falls. This could allow for water collected on the South Transept East Roof and East Aisle roof to be separated and taken straight to ground, as shown in the diagram below.
