The Cathedral and Metropolitical Church of St Peter in York

Design & Heritage Report for CCM Application

Revision A04 February 2026

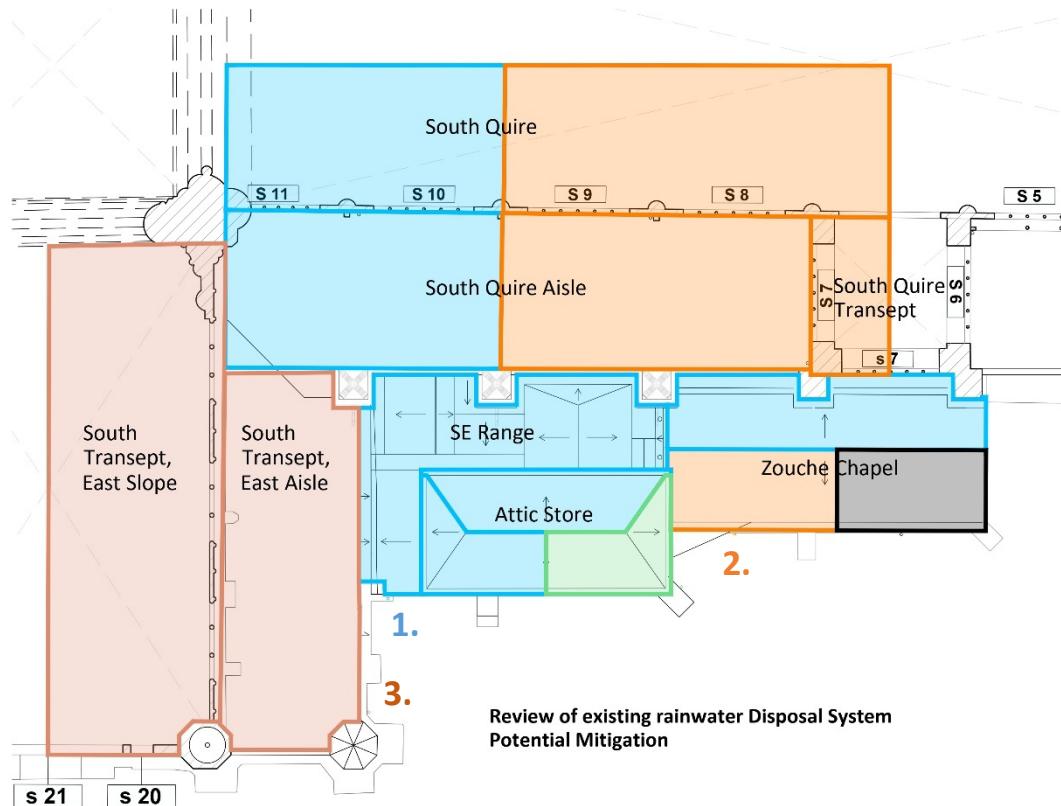
Whilst not fully alleviating the capacity issues of the system, this proposal would relieve DP 1 of rainwater discharging from an effective catchment area of approx 544m² and therefore c. 11l/s for a 1 in 1 year event, or 26l/s for a 1 in 50-year event.

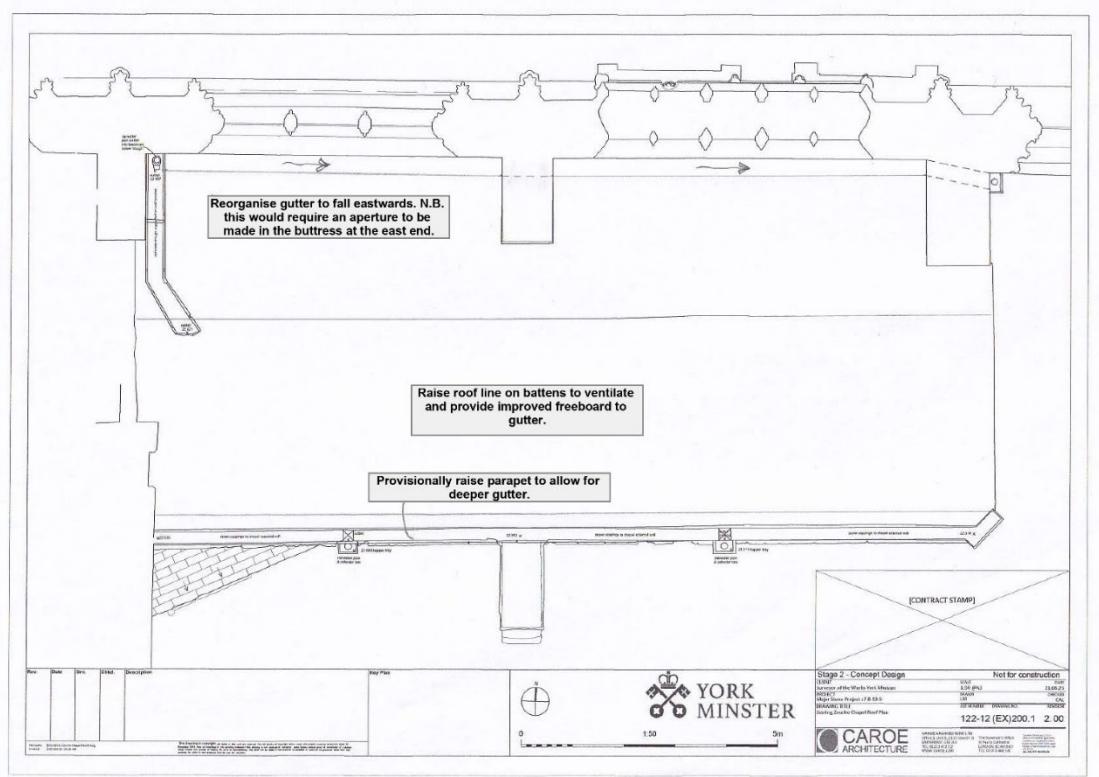
Potential modifications to be considered with re-roofing to improve gutter capacities.

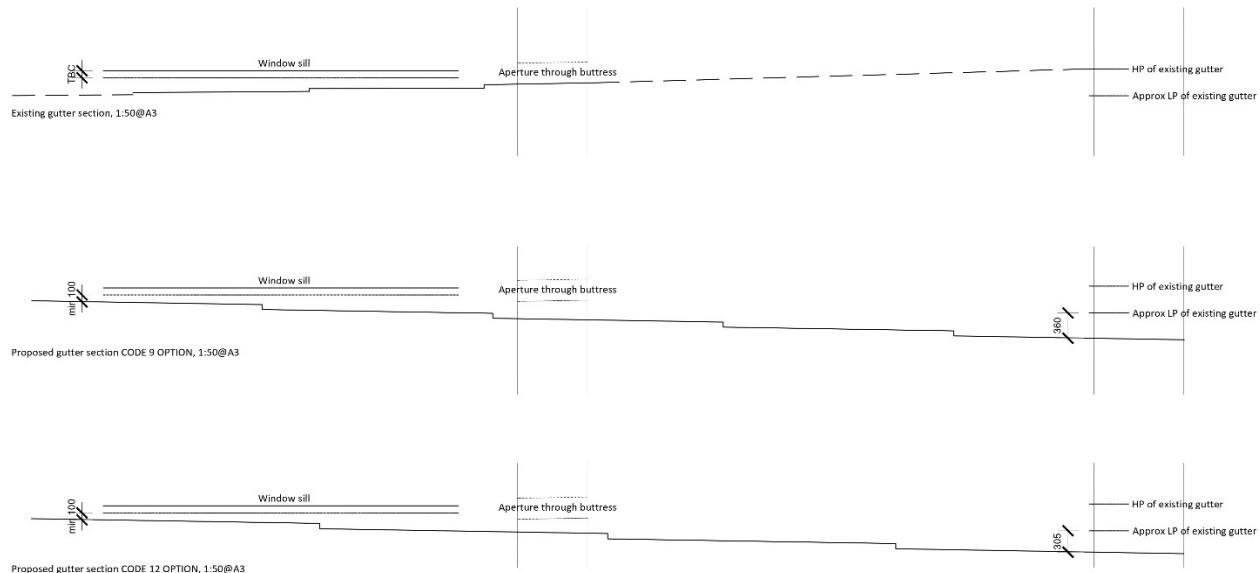
Studies into the layout of the north gutter to improve capacity, steps and falls, with limited overall depth available (restricted by sill heights and existing structure).

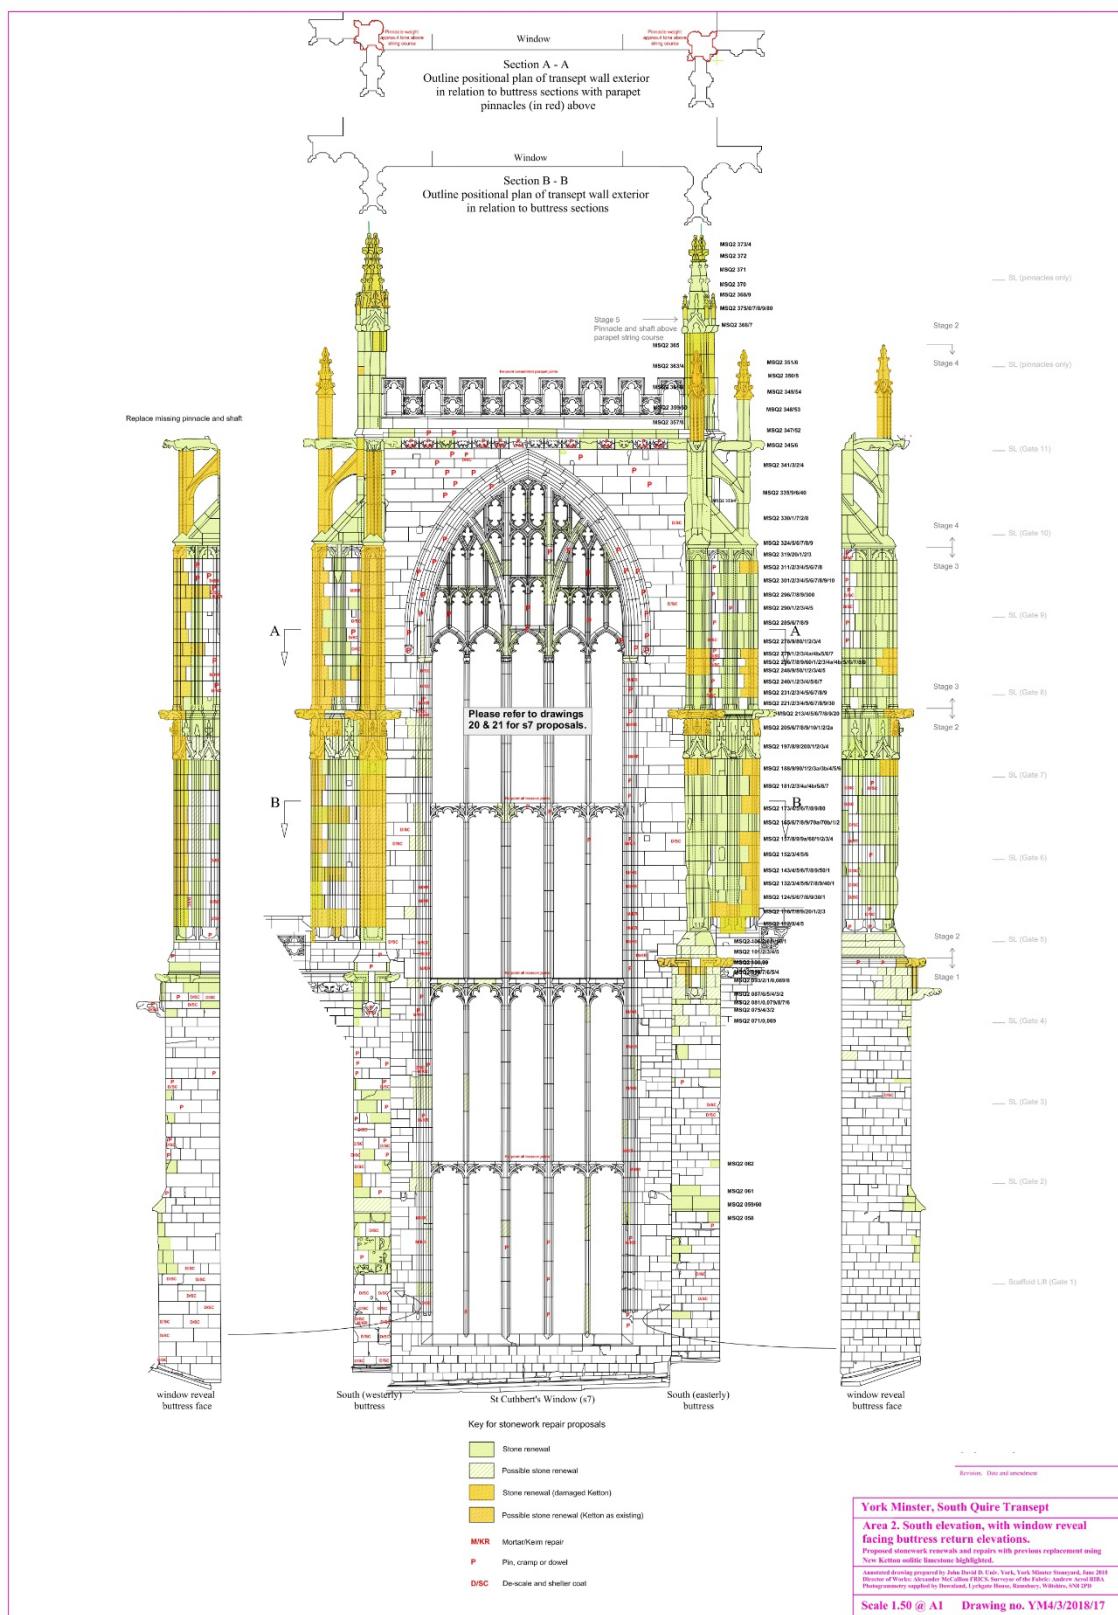
Area 2 (SQT), South Elevation with window reveal facing buttress return elevations: Proposed stonework renewals and repairs with previous repairs using new Ketton oolitic limestone highlighted.

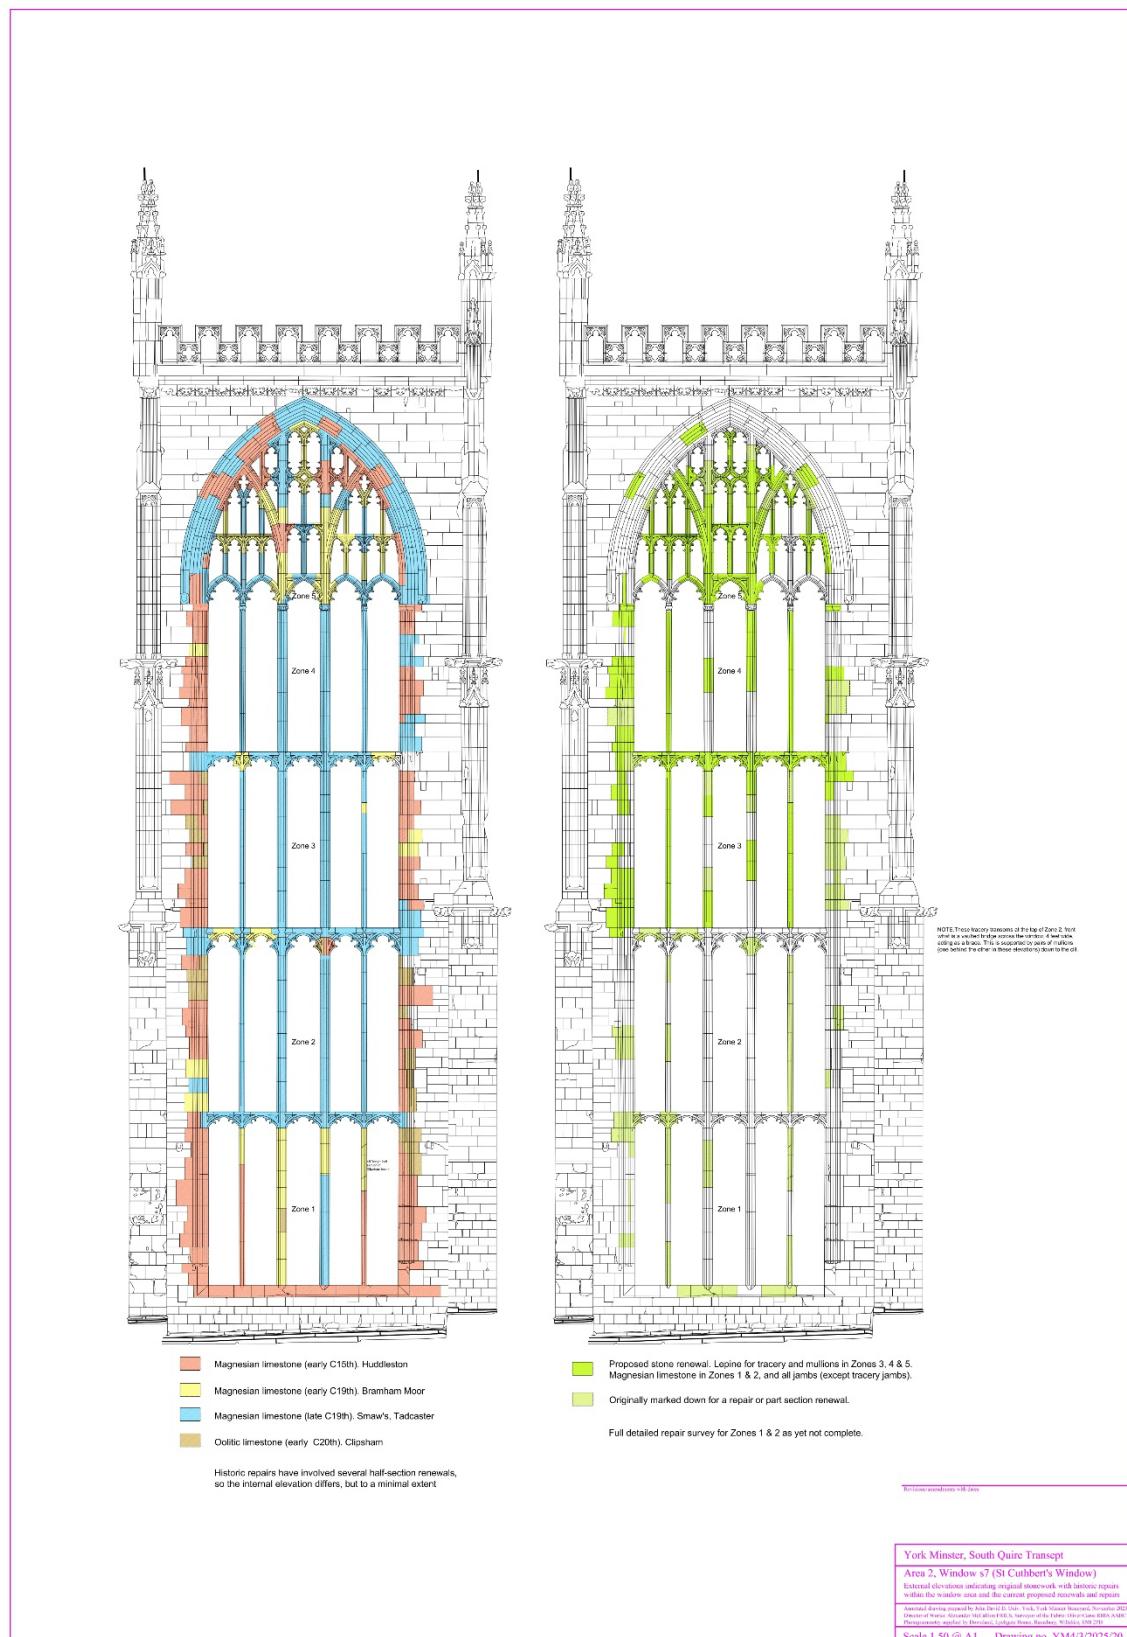
Area 2 (SQT), Window s7 (St Cuthbert's Window): External elevations indicating original stonework with historic repairs and stone types (left) and minimum extent of renewals suggested on the basis of condition (right).

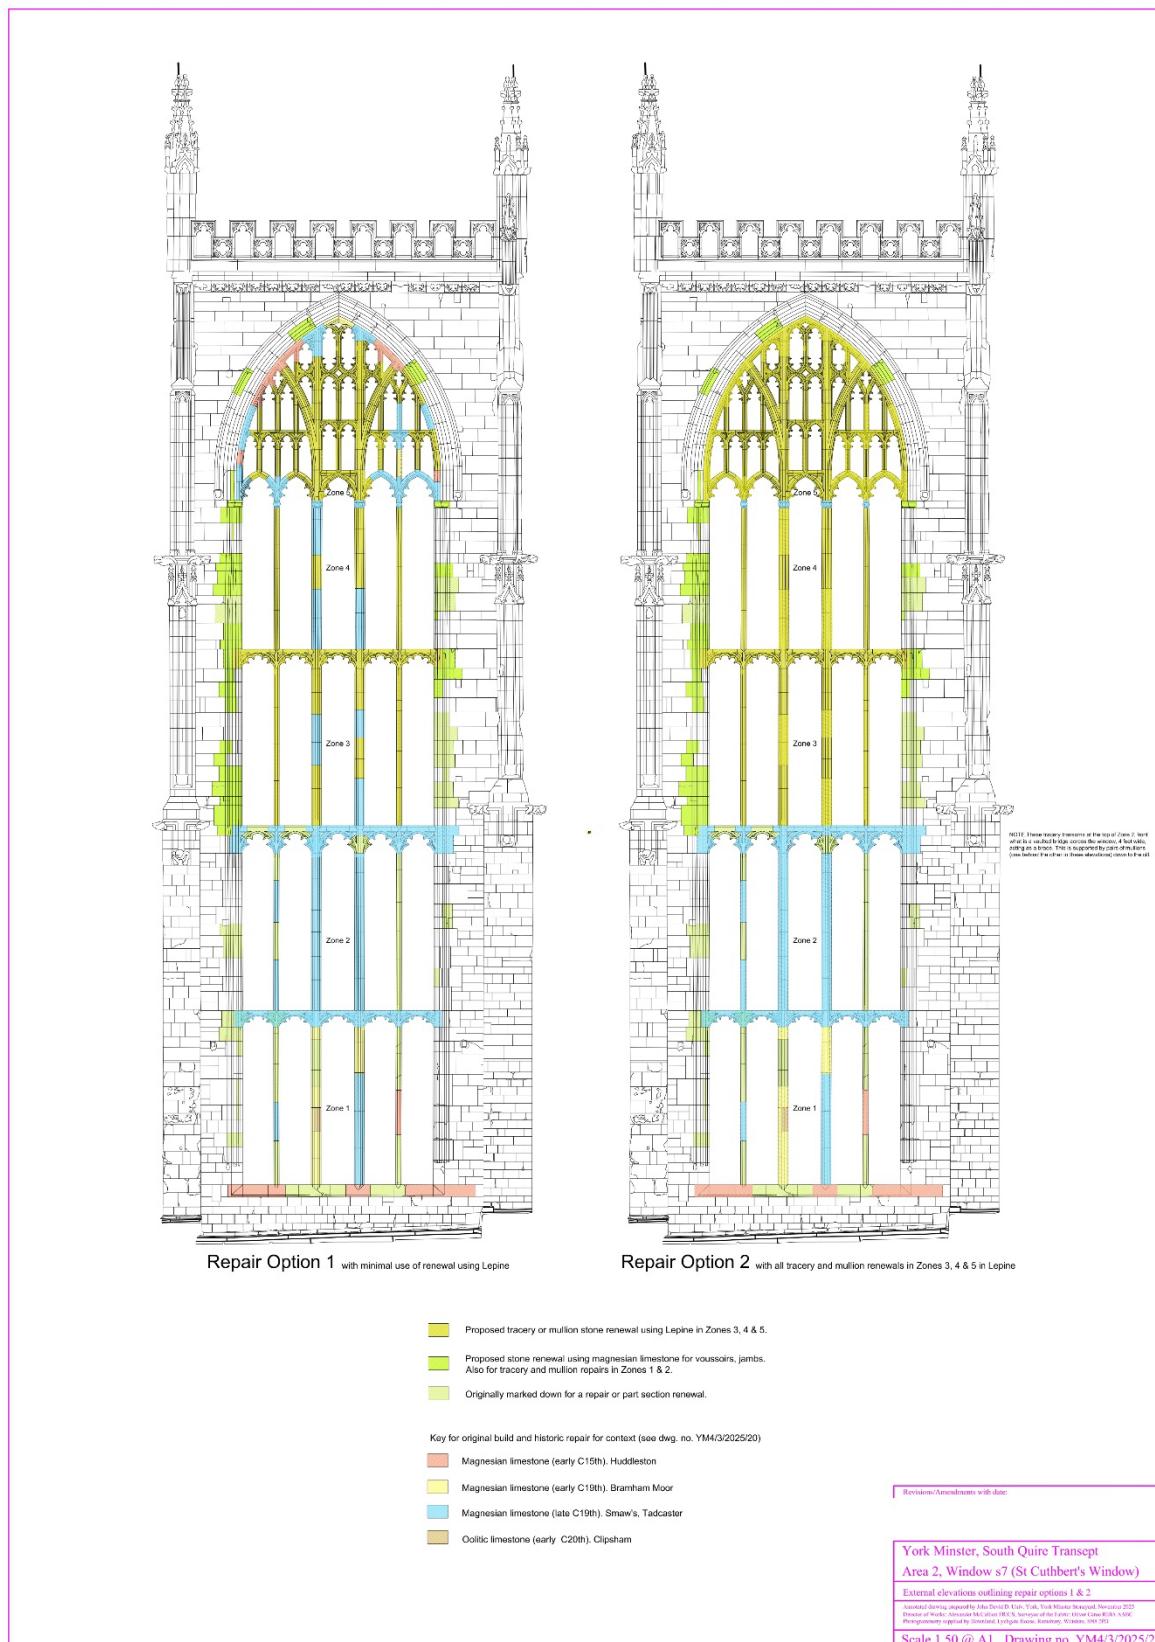
*Area 2 (SQT), Window s7 (St Cuthbert's Window): External elevations outlining repair options 1 (left) & 2 (right). **Option 2 is proposed for consent.***

Specifically regarding window s7 (St Cuthbert's window) we have evaluated and consulted upon two repair options which are presented in this report and shown on drawing YM4/3/2025/21. Following CFCE guidance especially, Option 2 is submitted for consent.

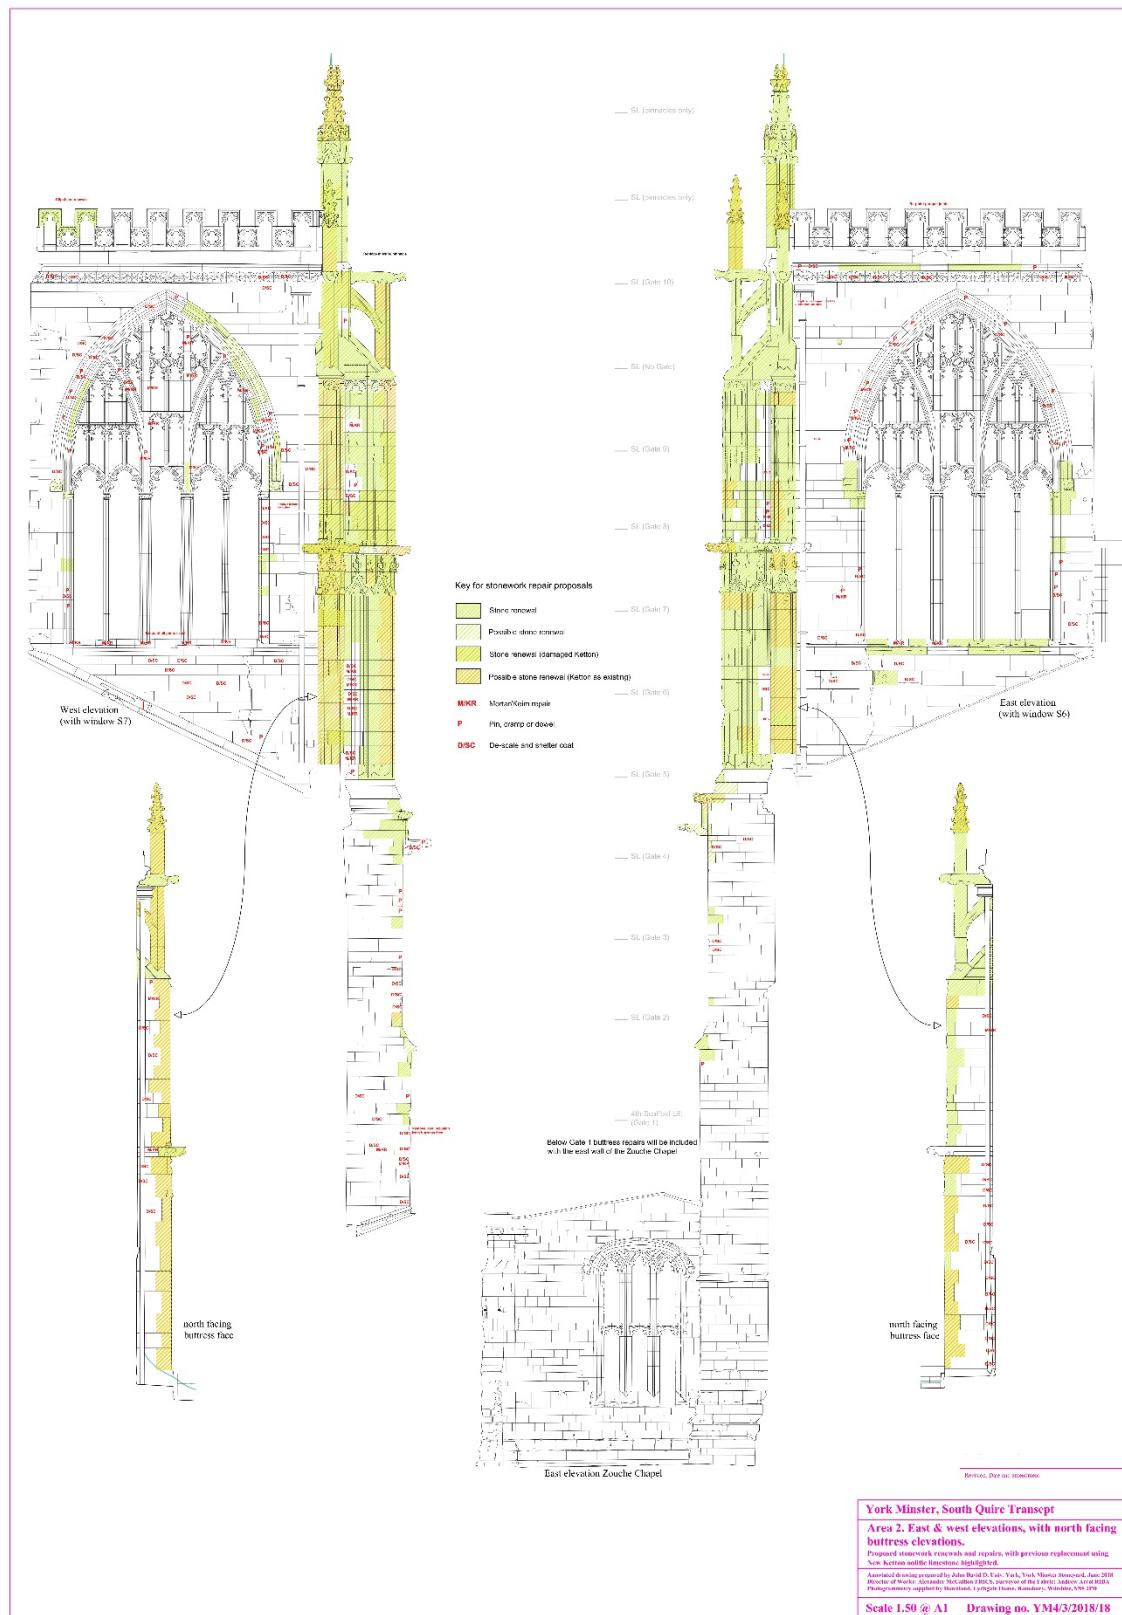
Area 2 (SQT), east & west elevations with north facing buttress elevations: Proposed stonework renewals and repairs with previous replacement using new Ketton oolitic limestone highlighted.

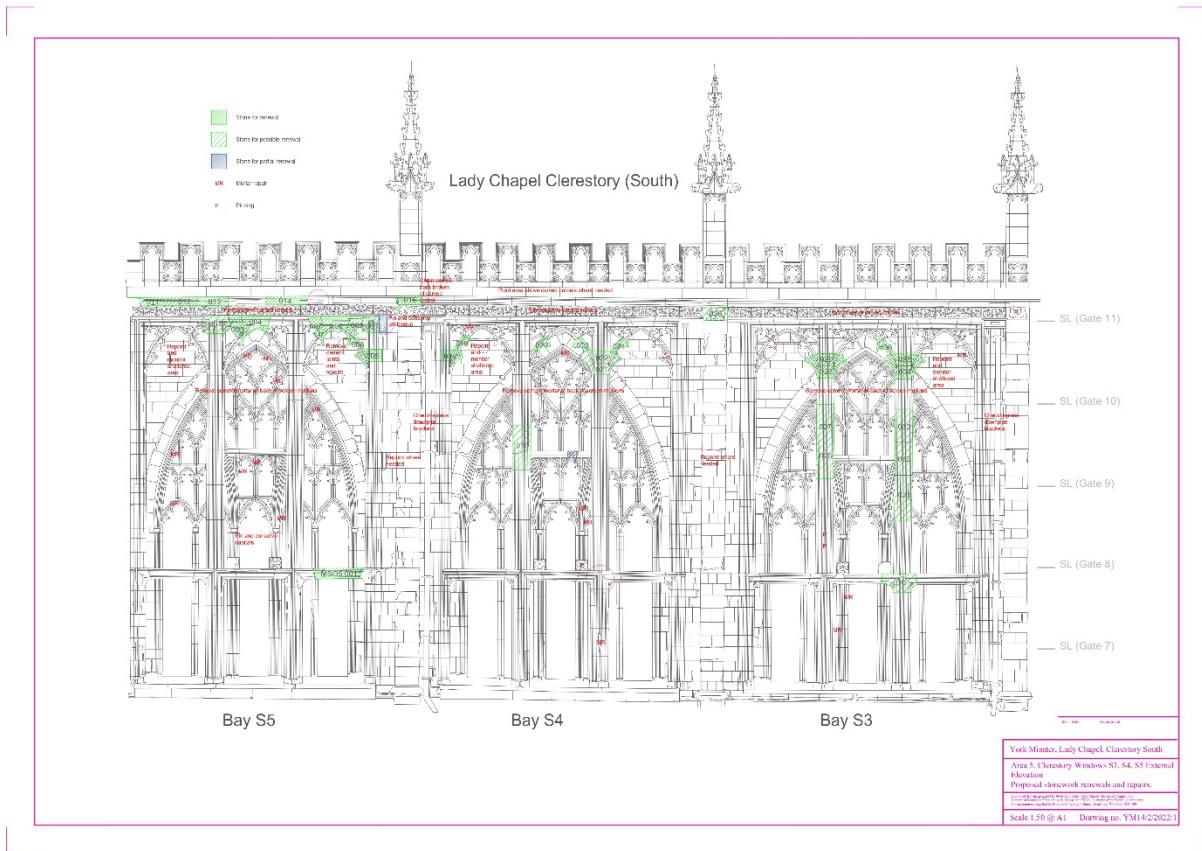
Area 5, Clerestory Windows S3, S4, S5 external elevation: Proposed stonework renewals and repairs to exoskeleton.
